## 2017 Ponderosa Way Road Assessment and Sediment Reduction Plan, Tehama County, California

PWA Report No. 171019201  
July, 2017

Central Valley Regional Water Quality Control Board (CVRWQCB)  
Proposition 1 Timber Fund Grants Program

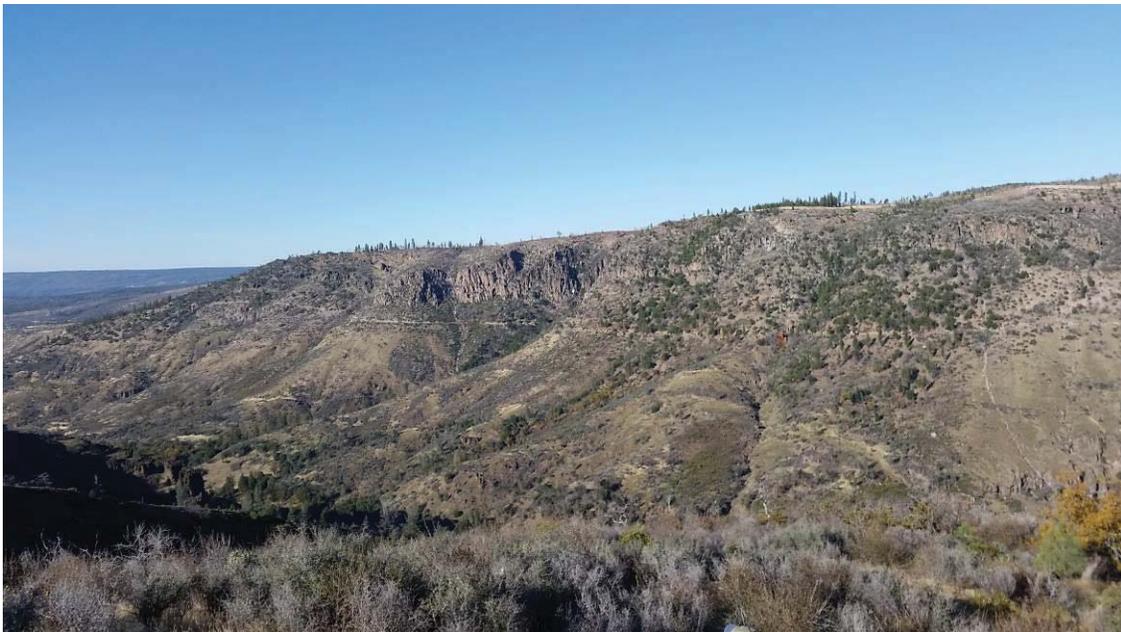
Photo 1. Ponderosa Way in the project area traverses the South Fork Battle Creek Watershed 27 miles northeast of Red Bluff, CA (see mid-slope road trace). The road was constructed in the 1930s in a middle hillslope position prior to more modern wildland road standards such as those defined by the California Forest Practice Rules. The road intercepts hillslope runoff, intermittently fails during storm events, and has caused downstream channel degradation.

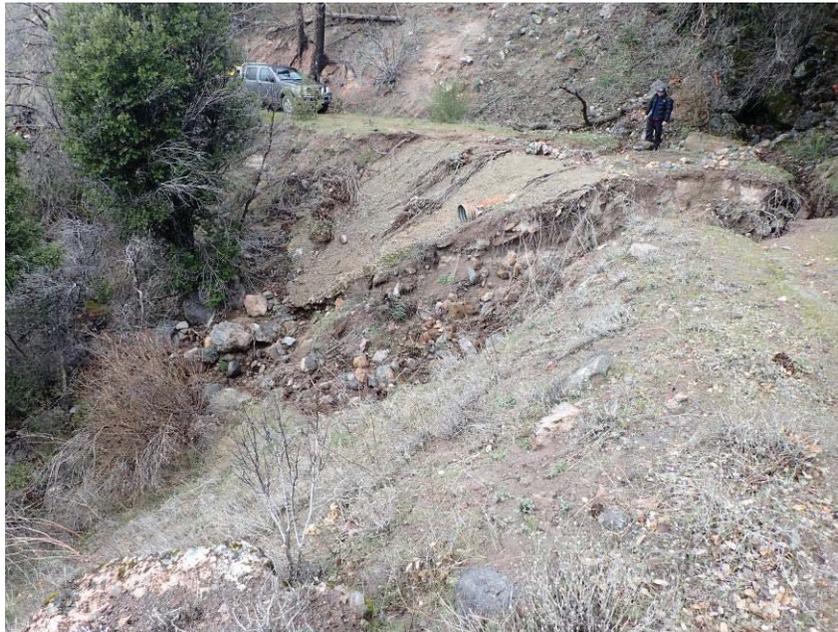
Photo 2. On the abandoned sections of Ponderosa Way, stream crossing culverts are undersized and many have plugged due to the magnitude of storm runoff during the post-fire period. Stream crossing washouts occur when culverts plug, sending the streamflow over the top of the stream crossing fill. Most washed out stream crossings, such as the one in this photo, have delivered the eroded sediment downstream and degraded the offsite channel.

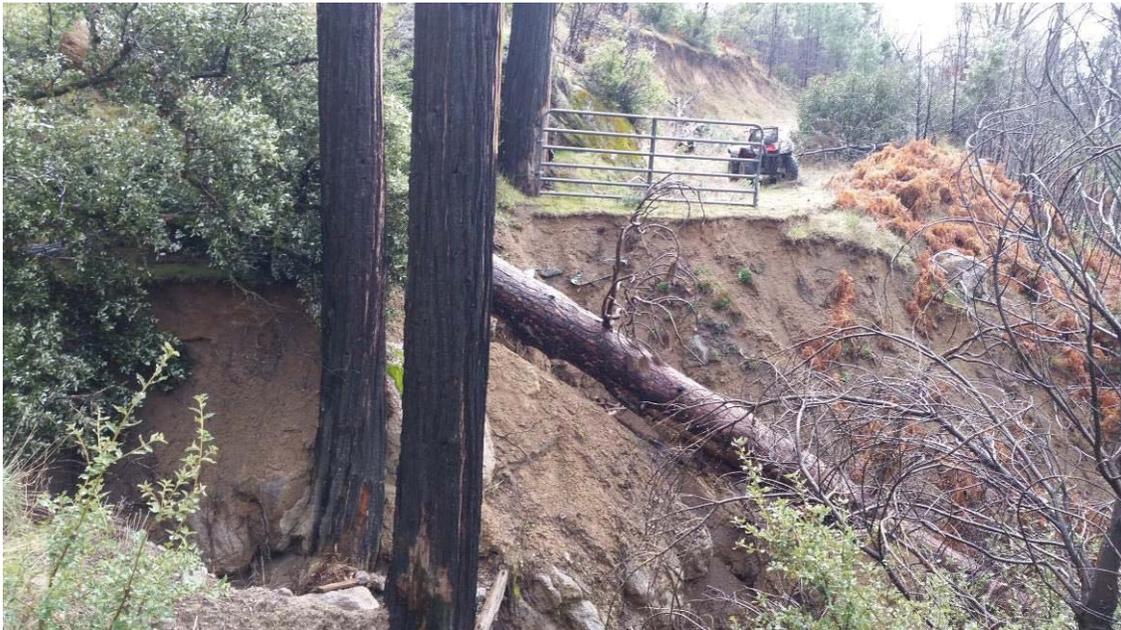
Photo 3. On a spur road, a washed out stream crossing and fillslope failure deliver sediment to Soap Creek (Sites #106 and #107). The road is impassable beyond this point.

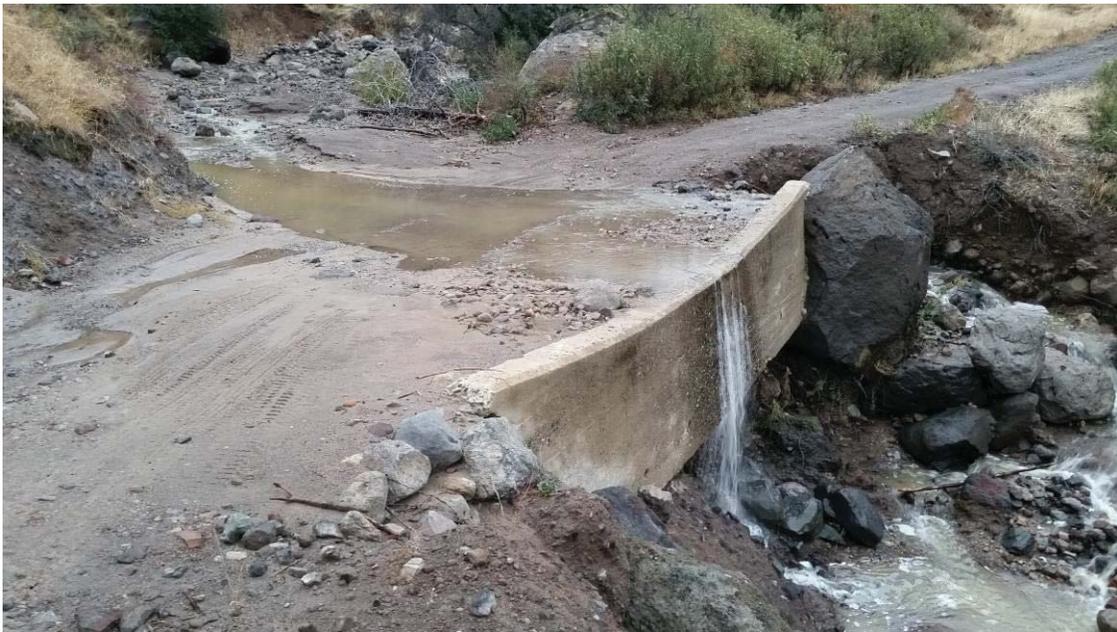
Photo 4. The concrete sill at this stream crossing (Site #26) is undersized for the peak storm flow. High flow flanks the stream crossing on the right and left hingeline. The stream has a 13.0 foot plunge off the center of the sill that has caused a scour hole and is subsequently undermining the concrete sill.

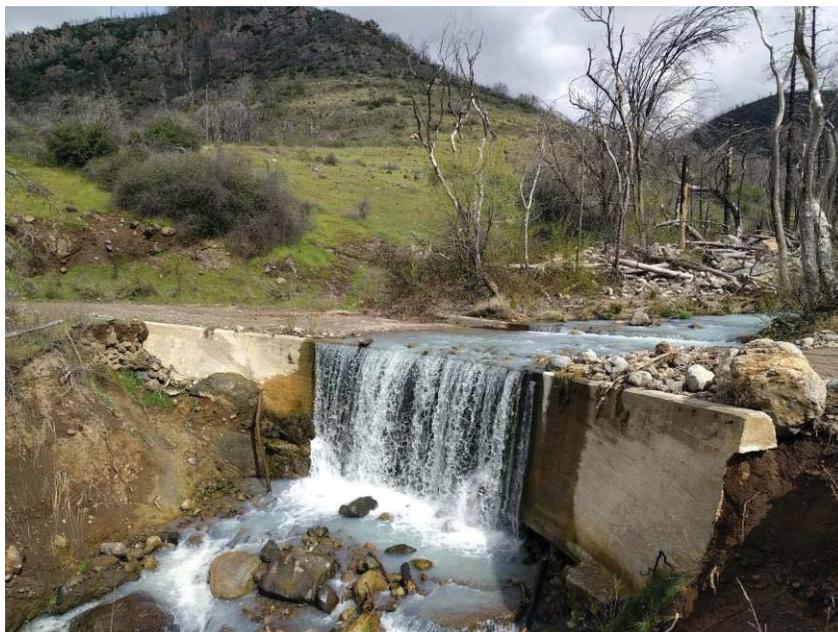
Photo 5. The concrete sill at this stream crossing (Site #27) is also undersized for the peak flows that occur at the site. High flow flanks the stream crossing on the left hingeline (right side of photo). The stream has a 14.0 foot plunge off the sill that has caused a scour hole and subsequently undermined the concrete sill.

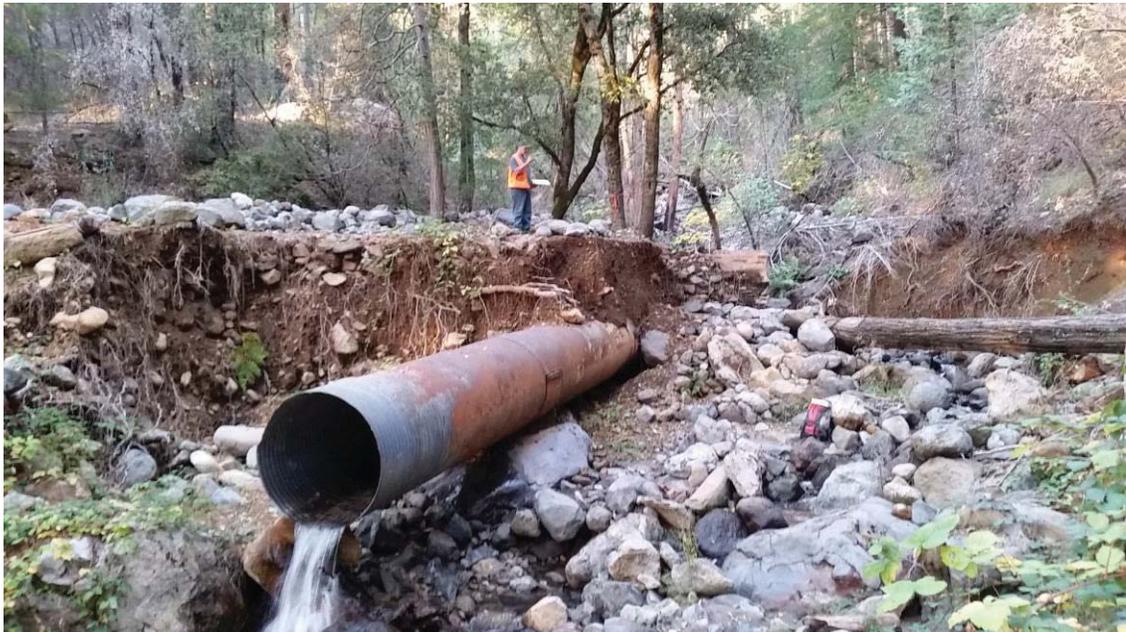
Photo 6. A post-fire debris flow plugged the culvert inlet at this stream crossing (Site #63). Flow overtopped the stream crossing and downcut through the road prism, washing out a large volume of sediment. Stream flow and large wood at the stream crossing culvert inlet continues to threaten the remaining, uneroded fill. Large boulders and cobbles have deposited on top of the former roadbed. Downstream, the stream channel is degraded by sediment delivered from the washed out crossing and debris flow.

Decommissioning this priority stream crossing by excavating and removing the remaining road fill will require approximately 8.0 hours of excavator and bulldozer work. Treating the adjacent road approaches with improved road surface drainage can be accomplished by ripping the road surface and constructing frequent cross road drains. Decommissioning this site will prevent approximately 365 yd<sup>3</sup> of sediment from entering the stream system.

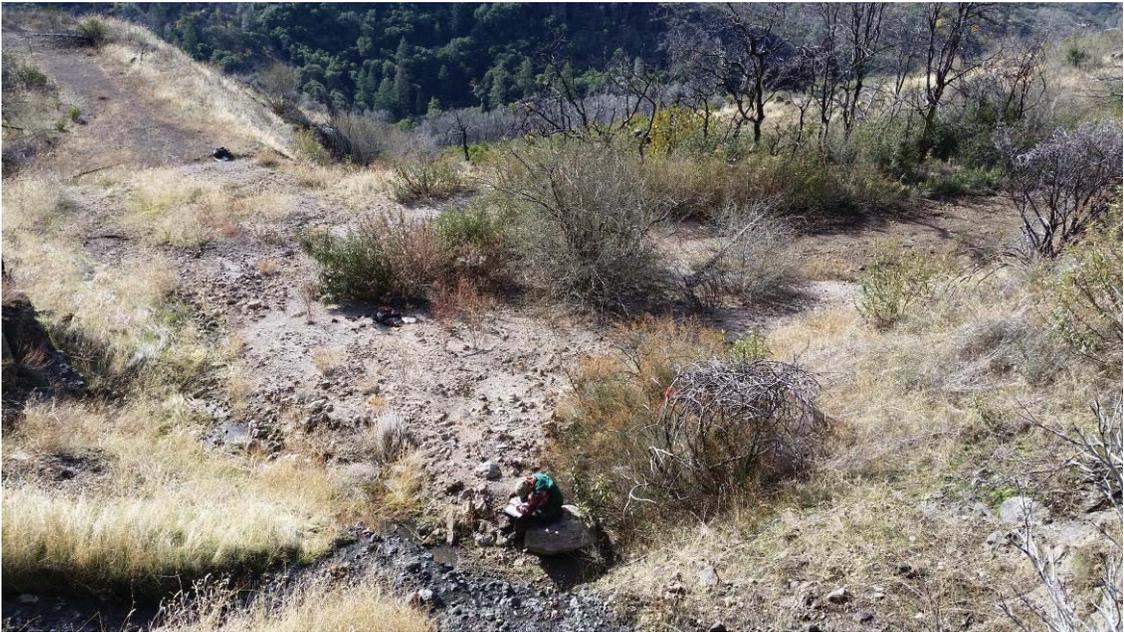
Photo 7. A debris flow plugged the culvert inlet (note person sitting next to plugged culvert inlet) at this stream crossing (Site #56). Flow overtopped the stream crossing and deposited sediment on the surface of the road. Streamflow diverted to the left and eroded approximately 20 yd<sup>3</sup> of road fill before reentering the watercourse. The remaining volume of erodible material at the stream crossing is a priority for treatment (excavation) before next winter's storm events.

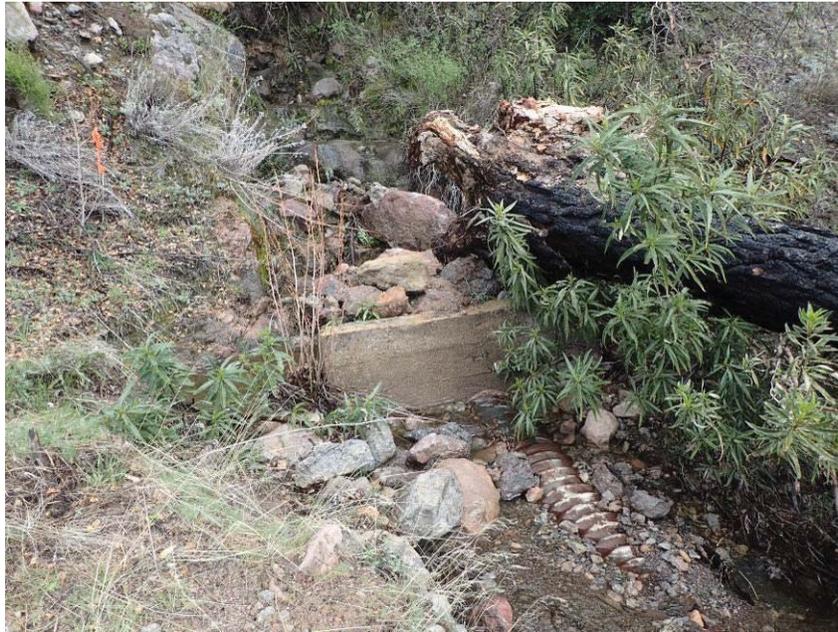
Photo 8. A debris flow plugged the culvert inlet at this stream crossing (Site #38, looking upstream at culvert inlet headwall). Flow overtopped the stream crossing, washed out (eroded) approximately 50% of the road fill material, diverted down the road alignment causing road surface gullies and hillslope erosion, and then reentered its original watercourse.

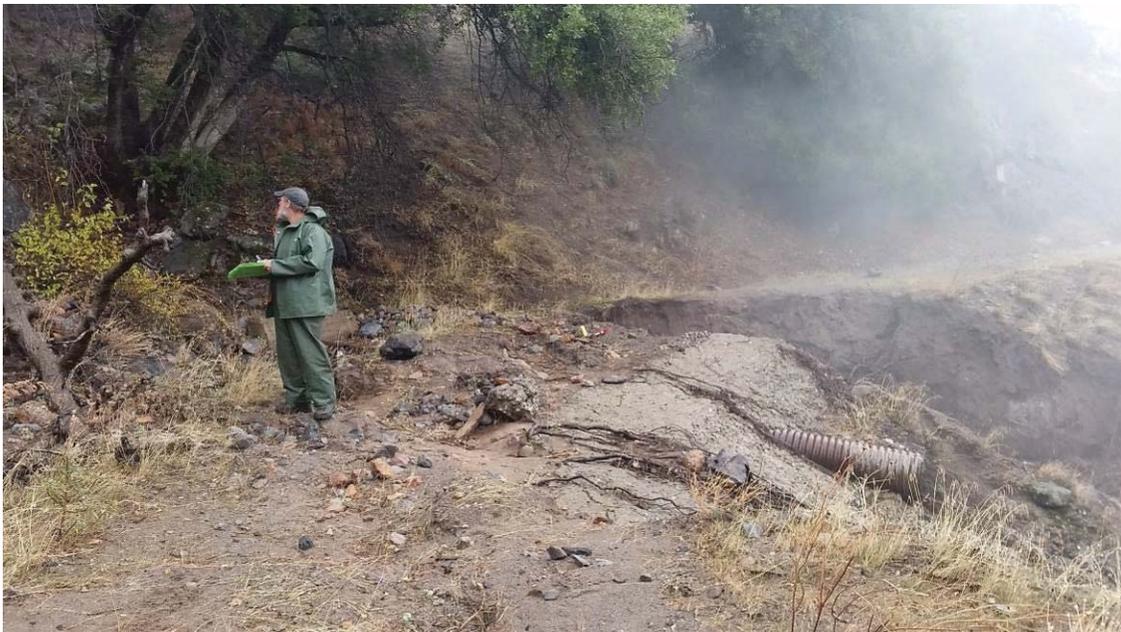
Photo 9. A debris flow plugged the culvert inlet and flanked the concrete sill at this stream crossing (Site #37). Flow overtopped the stream crossing and washed out approximately 25% of the road fill material that was then delivered to the steep stream channel. The road is impassible with vehicles or ATV's beyond this site; access to the south can be obtained only on foot.

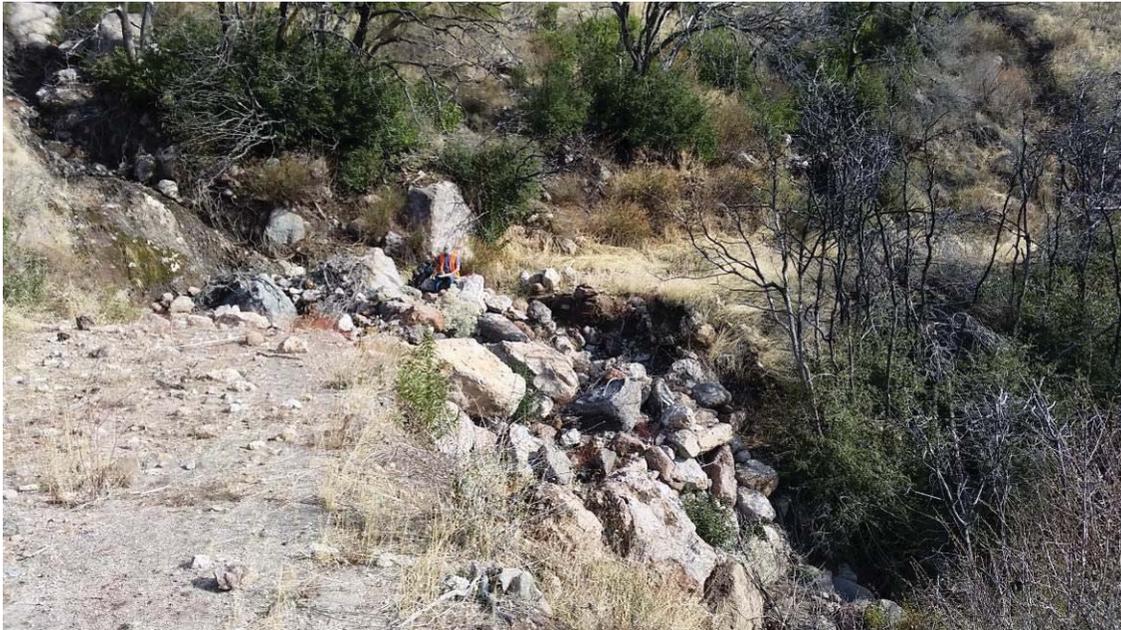
Photo 10. A debris flow plugged the 12 inch diameter culvert and washed out this stream crossing (Site #49). Flow overtopped the stream crossing and washed out almost 100% of the road crossing fill material. Debris flow material and boulders now reside at the stream crossing. Several of the mobilized large boulders are over 5.0 feet diameter. Crossings like this should have been strongly dipped and designed to accommodate intermittent debris flows from the upslope watershed.

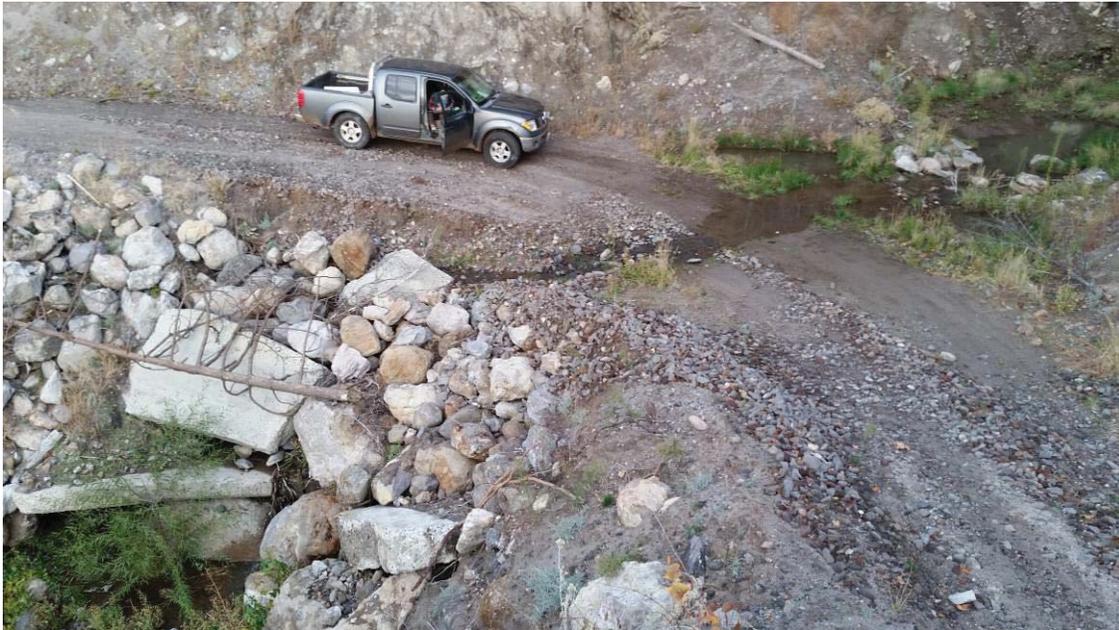
One feature in the project area has a future chronic and episodic sediment delivery volume greater than 500 yd<sup>3</sup> (Site #34; Photo 11). Feature #34 is a relatively large intermittent stream with an armored fill (no culvert) that was recently reopened and maintained to gain access further south onto Ponderosa Way. The road's outer fillslope is protected with large boulders and rocks that were intended to protect the crossing fill from eroding and washing out.

Photo 11. An armored fill at a stream crossing (Site #34) was recently reopened and maintained to gain access south on Ponderosa Way. The armored fill at the stream crossing was not constructed properly, is currently slumping, and shows signs of potential failure and imminent sediment delivery. This stream crossing has the 4<sup>th</sup> largest volume of potential erosion and sediment delivery for the project area (501 yd<sup>3</sup>).

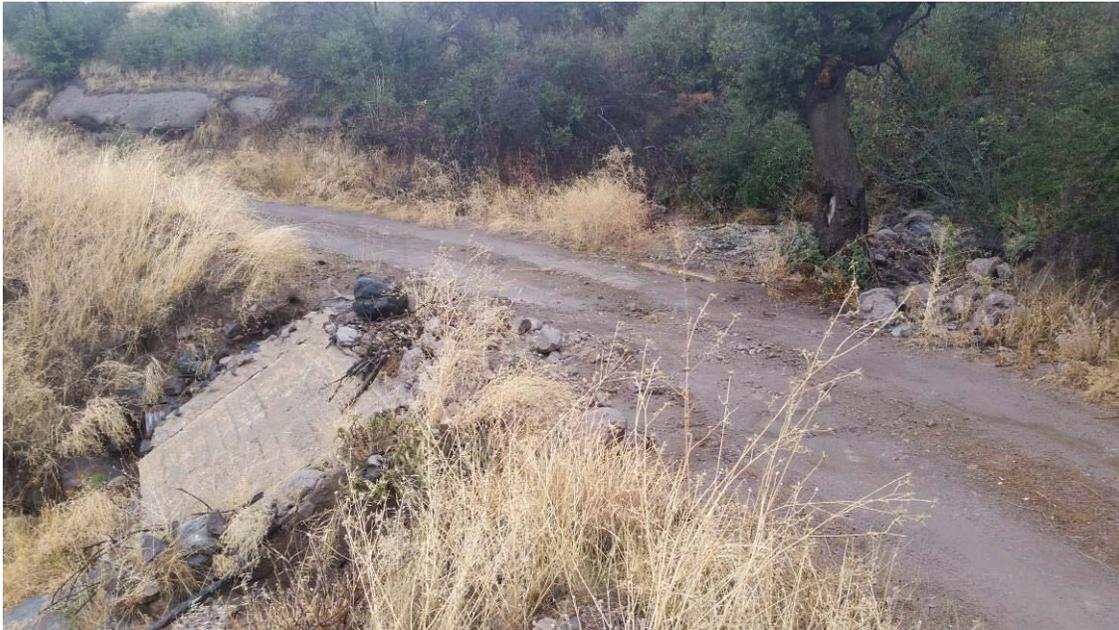
Another large fill volume site in the project area that has an estimated future chronic and episodic sediment delivery volume greater than 278 yd<sup>3</sup> is Site #22 (Photo 12). Site #22 is an intermittent Class II watercourse with a concrete sill protecting the road fill. The current culvert (24 inch diameter) is set high and short in the fill and it plugged with sediment following the post-fire flooding (not visible in photo). The stream crossing's outer fillslope is protected with a concrete apron that was undersized and nonfunctional during high flows. There was also evidence of gully erosion and downcutting of the fill prism. At the base of the concrete apron high flows have created a scour hole and eroded the stream channel below its natural grade; the sill has also been undermined. The road surface at this site is unrocked and built on a low gradient road approach that has eroded and delivered fine sediment to the stream system at the crossing. Upgrading this stream crossing will prevent approximately 278 yd<sup>3</sup> of sediment from entering the stream system, if it were to fail entirely.

Photo 12. A debris flow plugged the 24 inch diameter culvert and flanked this stream crossing (Site #22). Stream flow then overtopped the stream crossing fill and washed out approximately 10% of the crossing material. Downstream the channel is degraded and incised.

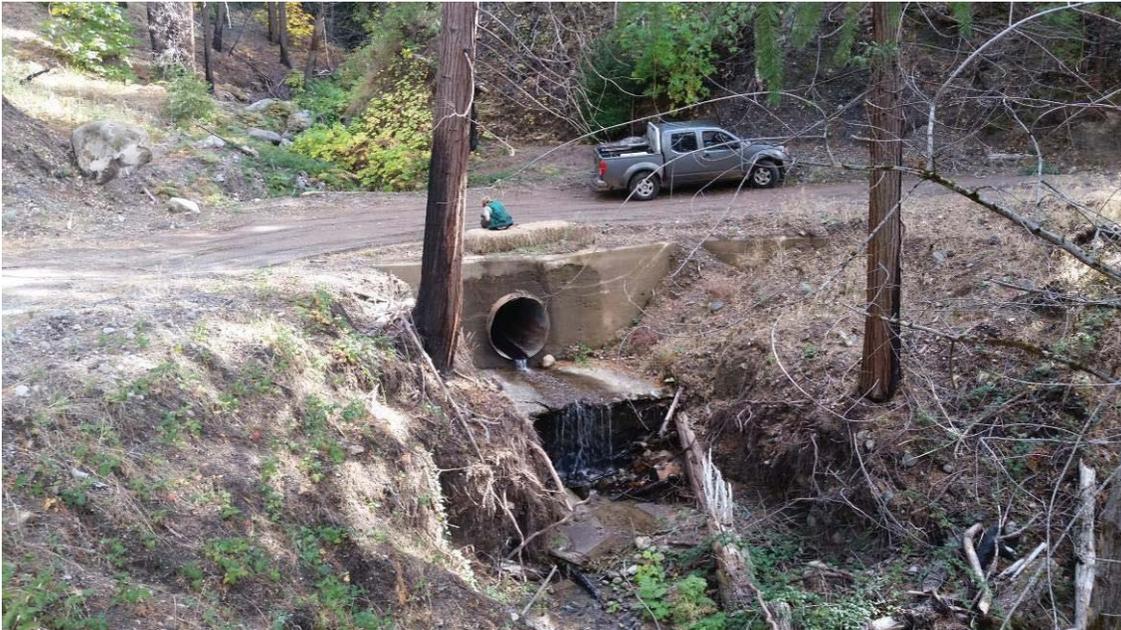
Photo 13. A Class II watercourse with a 48 inch diameter culvert and concrete wall protecting the culvert inlet and outlet. This is one of a few stream crossing that did not experience a debris flow. However, the culvert is undersized for the drainage area's estimated peak flows. At the outlet of the culvert, a plunge off the flow dissipation apron creates a scour hole, erosion, and sediment delivery.

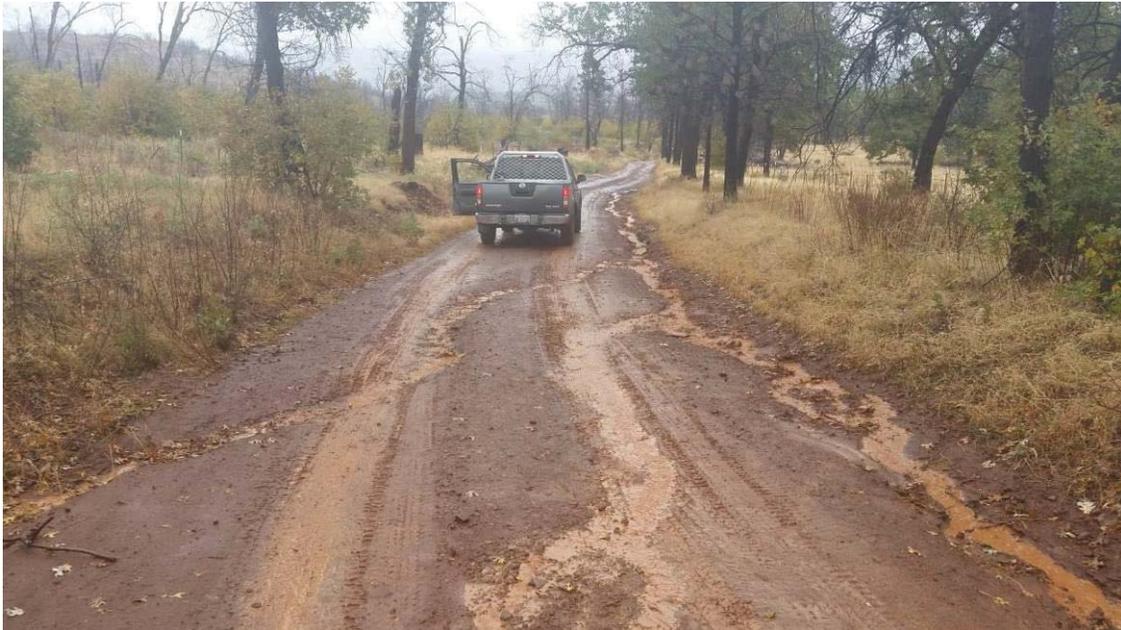
A through-cut road will collect a large volume of rainfall (Site #4). Berms or cuts on both sides of the road trap road surface runoff until it eventually forms rills and gullies. At Site #4, PWA field crews measured 5,000 feet of hydrologically connected road and estimate that 300 yd<sup>3</sup> of potential future erosion and sediment delivery will occur in the next decade if no road drainage improvements are performed. This road segment has been recommended for road upgrading. In general, especially on high use road segments, road surfaces will need to be upgraded by reshaping and construction of road drainage structures (e.g., rolling dips and ditch relief culverts) to disperse road surface runoff sufficient to prevent road surface and hillslope gully and to improve long term, dispersed road drainage. Road upgrading techniques are described in

Photo 14. Road surfaces, berms and ditches capture and transport hillslope runoff and direct rainfall during storms. Road surface and ditch runoff often flow down the road grade and directly into stream crossing culvert inlets. This photo shows a long road segment with uncontrolled road runoff during a rainfall event. The road surface is unrocked and sediment is eroded and transported in several rills and gullies down the road. This road segment is without a drainage point for over 5,900 feet. The sediment that is in transport and eventually delivers fine road related material to a stream crossing located at Site #4.

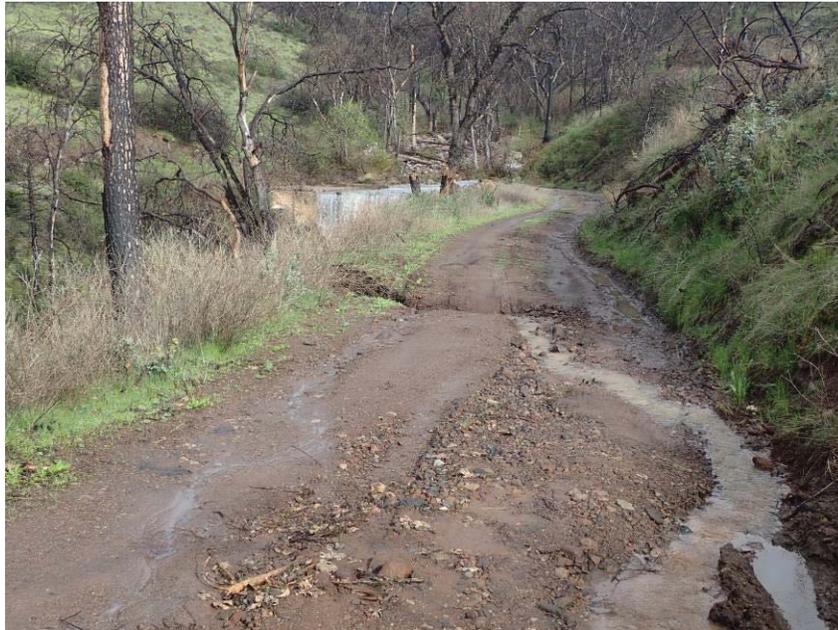
Photo 15. At Site #27, a long road segment concentrates road runoff inside the ditch on the inside of the road. During storms, the road surface and inboard ditch transports runoff and sediment to the stream network. Concentrated road surface and ditch runoff flows down the road with increasing velocity and discharge, creating surface erosion, rills and small gullies. In this photo, the runoff is focused in the ditch along the inside of the road; when it encounters a waterbar, the runoff exits road delivering fine sediment to Soap Creek at the base of the road fill.

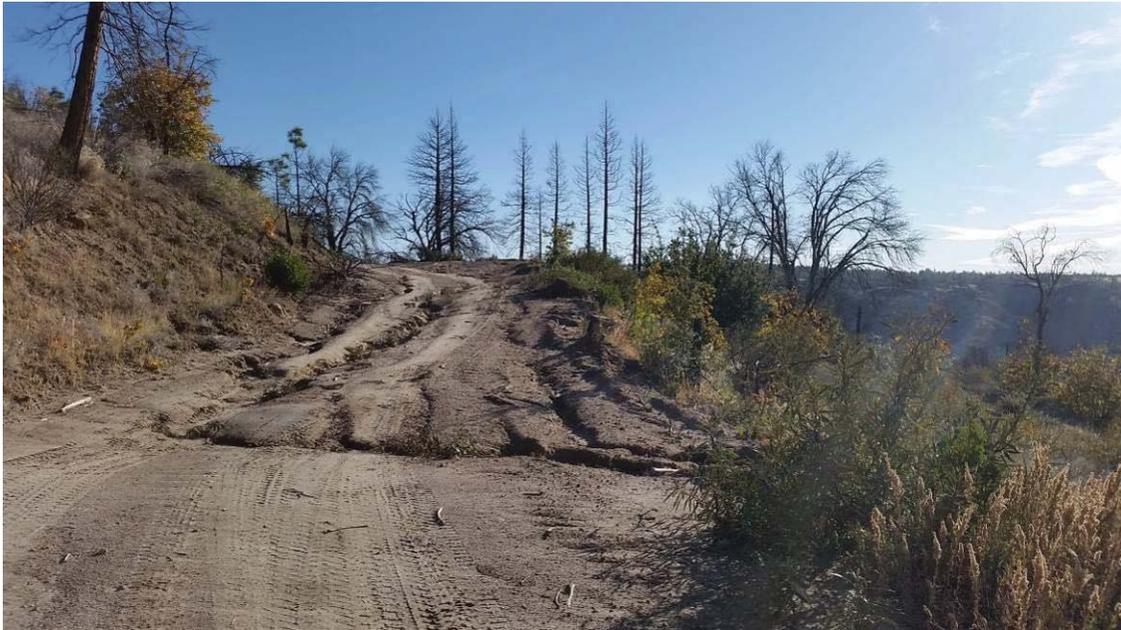
Photo 16. Roads that are flat in cross section, with an outside berm and inside ditch, intercept upslope runoff and do not allow the runoff to leave the road. At Site #39, a long road segment intercepts hillslope runoff that has increased due to the 2012 Ponderosa Fire. Uncontrolled road runoff during a storm eroded the road surface and transports concentrated runoff and eroded sediment to the nearby stream network. In this photo, the runoff is trapped by a berm on the outer edge of the road and sediment is transported in several large rills and gullies down the roadbed until it leaves the road prism.

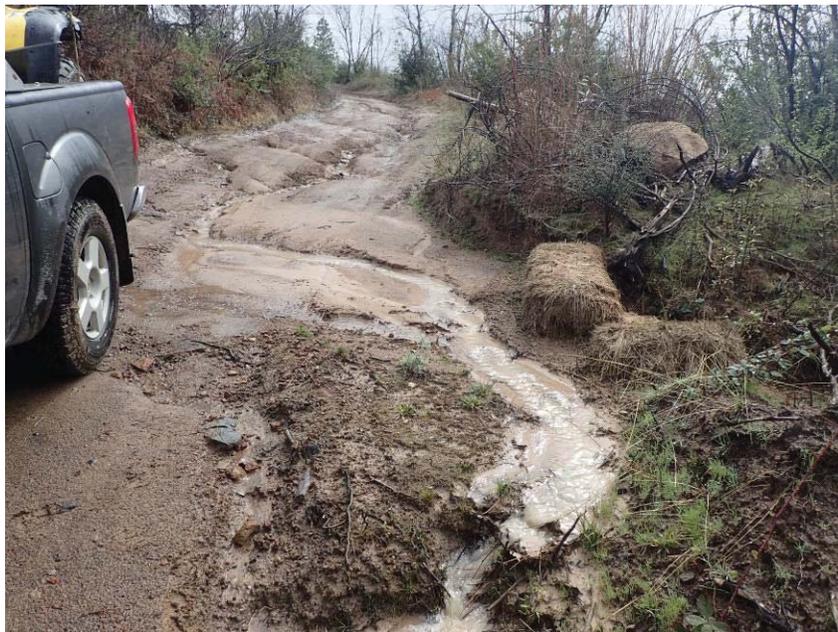
Photo 17. On Ponderosa Way, a berm has formed after years of routine grading and road surface erosion. The berm captures and concentrates road runoff, preventing it from being dispersed onto the hillside, and accelerates road surface and ditch erosion rates. Rills and gullies have formed in the roadbed and increase in size each storm. Sediment delivered from these gullies can be prevented by dispersing runoff in more frequent locations through road surface outcropping or construction of rolling dips and ditch relief culverts.

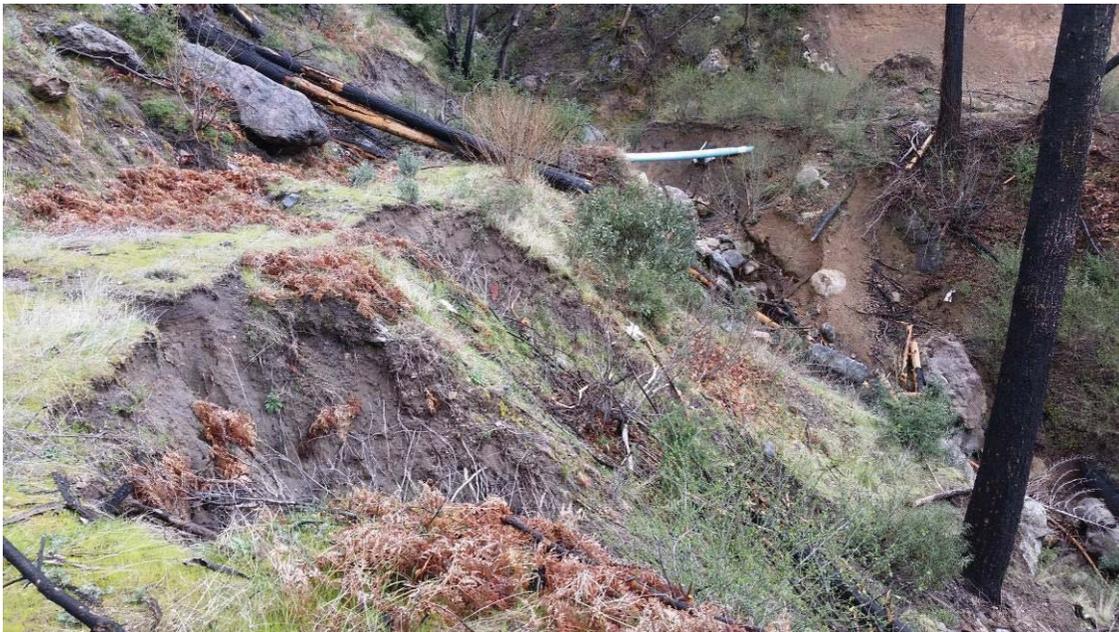
Photo 18. Site #104 is a washed out stream crossing that delivered approximately 110 yd<sup>3</sup> of eroded sediment to the Soap Creek stream system. This spur road has a buried 12 inch diameter waterline that diverted stream flow in the past, before the failure occurred. In the photo's foreground, two upslope gullies caused fillslope erosion and eventual failure of the fill along the outer edge of the road prism, causing an estimated 84 yd<sup>3</sup> of erosion and sediment delivery.

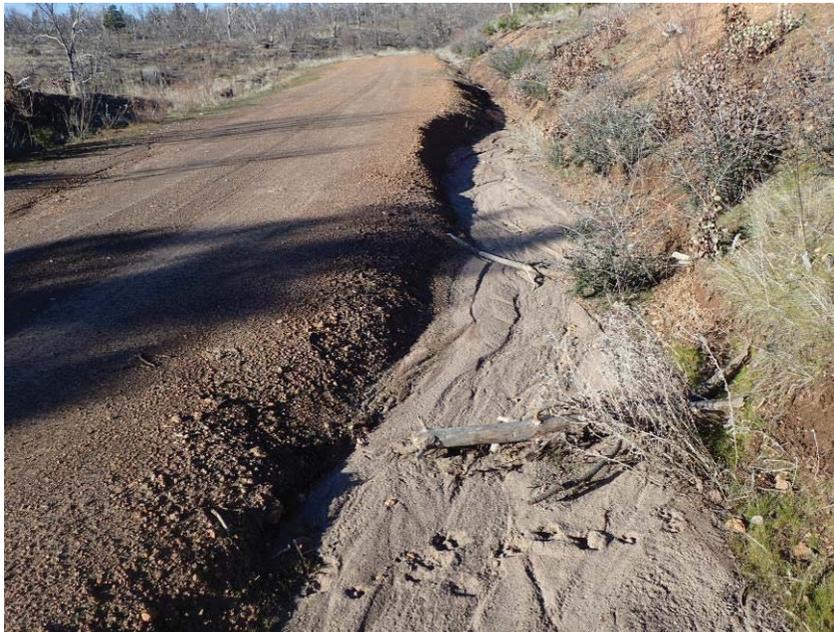
Photo 19. Ditches convey road surface runoff and intercept hillslope runoff from burned and unburned slopes. Ditches transport concentrated runoff directly to watercourses, increasing stream channel peak flows and sedimentation rates. These hydrologically connected road segments increase the magnitude and duration of turbidity and fine sediment delivery during both high and low intensity runoff events.

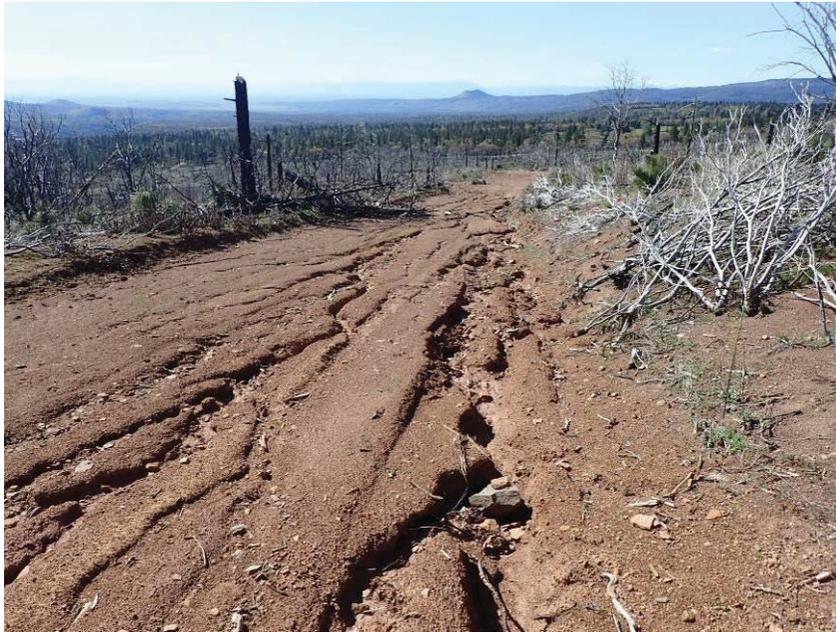
Photo 20. The roads in the Ponderosa Fire area are underlain by highly erodible and locally unstable geologic substrate, and both field observations and analysis of aerial photographs suggest that roads have been a significant source of accelerated sediment production from the burned areas. Wherever maintenance of road drainage features is lacking in the burned area, sediment production from roads is likely to stay at relatively high levels.

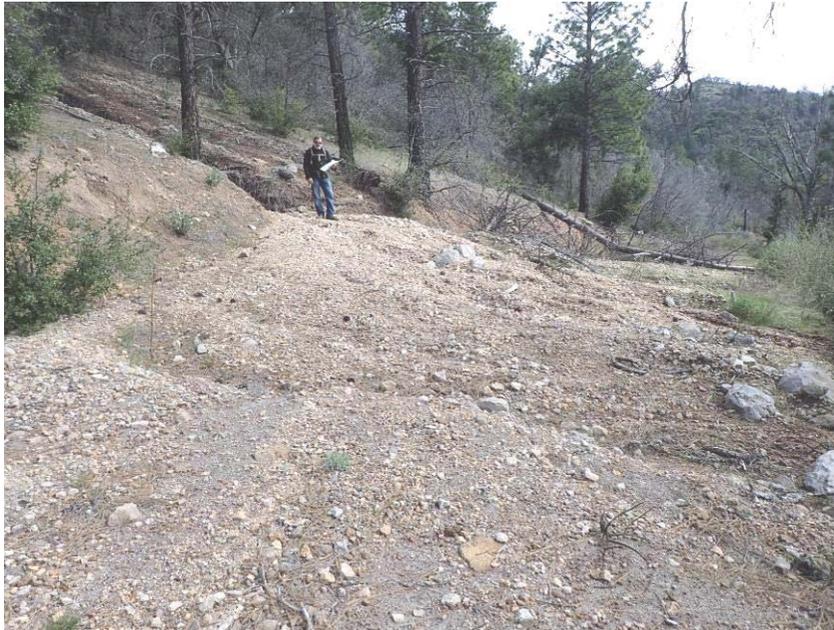
Photo 21. A debris flow deposited on the road at the abrupt change in channel grade (Site #57). The debris fan deposit on the road surface blocks vehicular access. Most of the material is composed of small angular material mixed with fines from post fire runoff. Flow overtopped the stream crossing and washed out approximately 20% of the road crossing material. Subsequent streamflow down these channels will either be diverted down the adjacent road bench and create a new channel (gully) down the hillslope, or it will eventually erode through the remaining road fill and debris flow deposit as it exhumes and reestablishes the original stream bed.

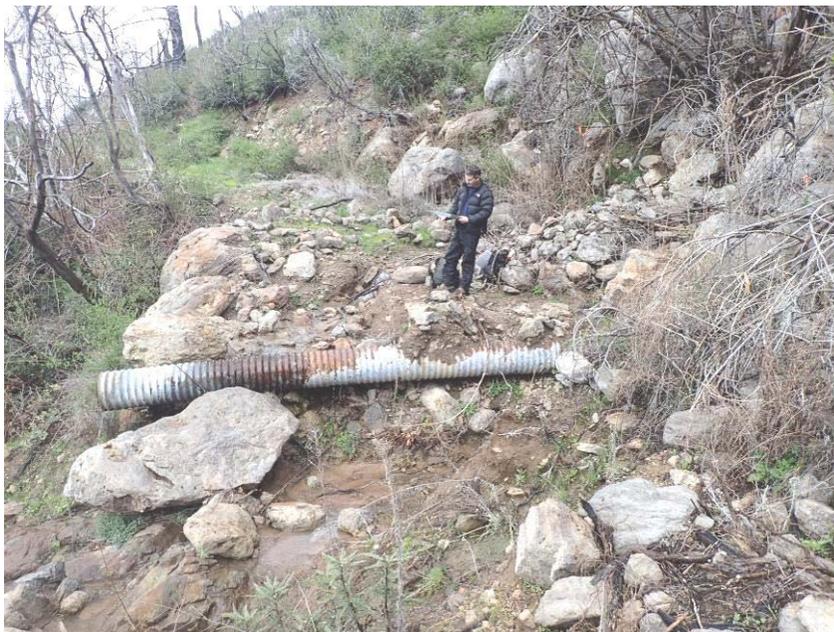
Photo 22. A Class III watercourse with a washed out 15 inch diameter culvert. The culvert was plugged by a small debris flow that subsequently caused overtopping and the erosion of the road fill (Site #40). The road is impassible beyond this site. We estimate that there is an estimated 161 yd<sup>3</sup> of future erosion associated with the site.

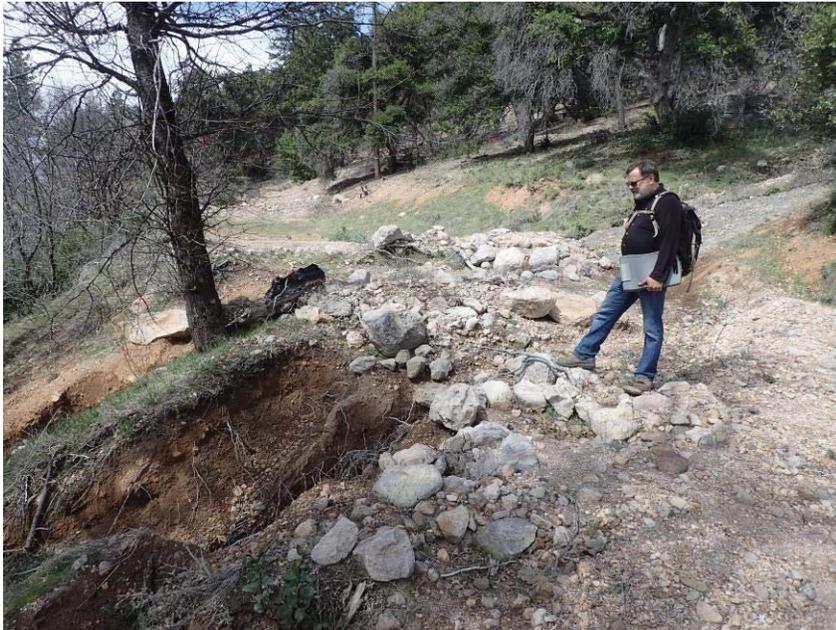
Photo 23. A Class III watercourse that experienced a debris flow that overtopped the road and caused channel incision and deleterious downstream effects (Site #57). Approximately, 20 yd<sup>3</sup> of road fill eroded and washed downstream. We estimate that there is approximately 62 yd<sup>3</sup> of future erosion associated with this site.

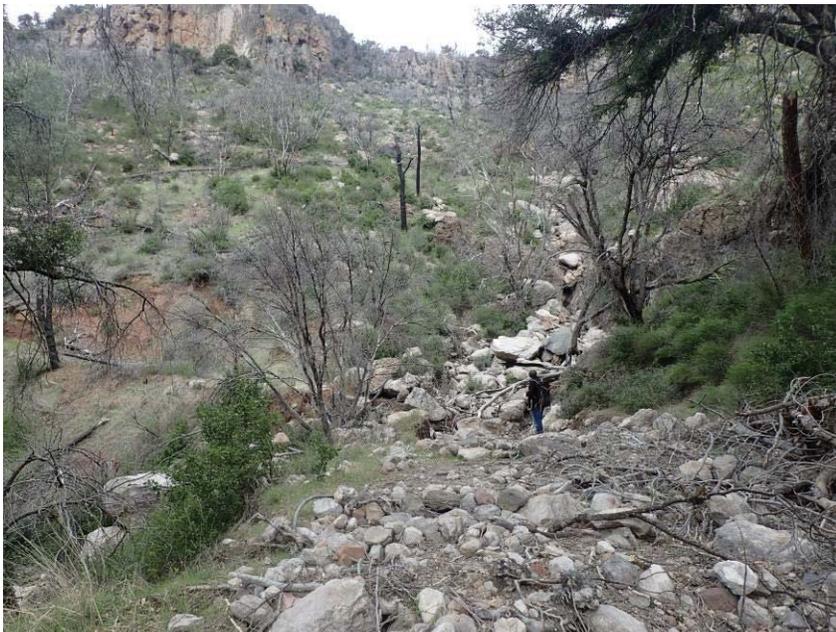
Photo 24. A debris flow containing very large boulders washed out Ponderosa Way and made it impassible beyond this point (Site #55; note person for scale). The undersized culvert at the crossing was plugged and the stream diverted down the road, causing significant hillslope gullies and sediment delivery. It was estimated that 80% of the road prism was washed away and replaced with debris flow materials, including very large boulders.

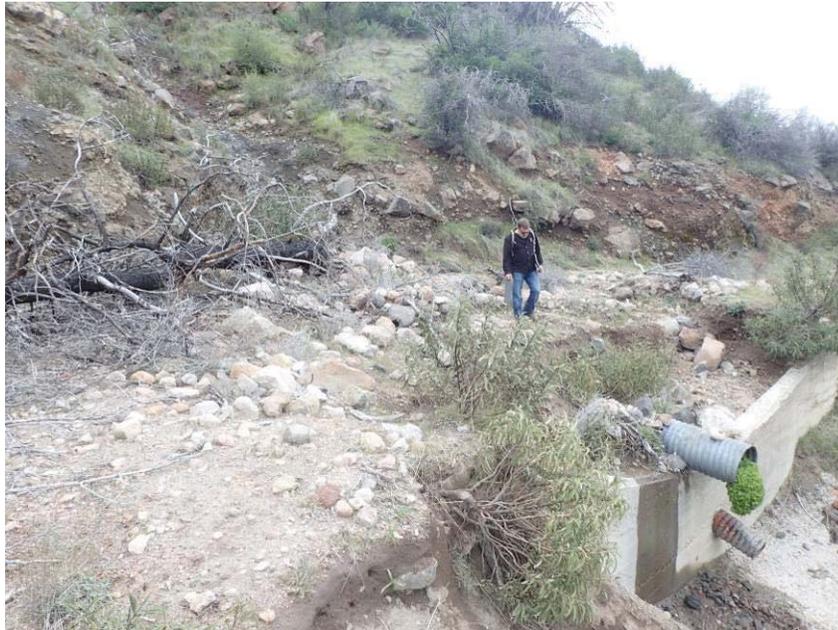
Photo 25. A debris flow washed out Ponderosa Way at this site and made it impassible beyond this point (Site #52). The undersized culvert was engulfed by the debris flow deposit and quickly plugged. It was estimated that 15% of the road prism washed away. PWA field crews measured the crossing geometry and estimated that 174 yd<sup>3</sup> of potential future erosion and sediment delivery is likely to occur if decommissioning the crossing is not completed in a timely manner.

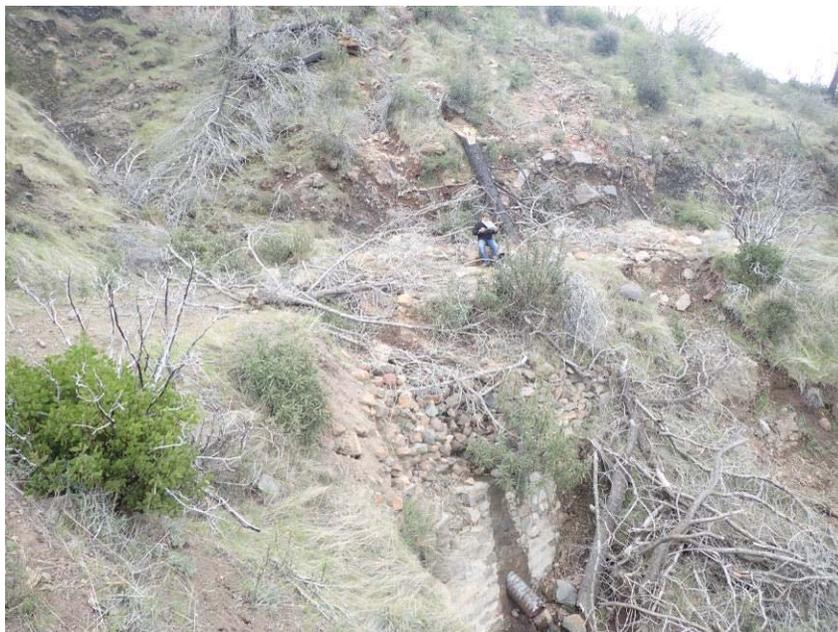
Photo 26. A Class II watercourse with an undersized culvert and stone revetment work (Site #51). A debris flow in this steep channel flowed over a 75 foot tall cliff. We estimated that 25% of the crossing washed out and 76 yd<sup>3</sup> of future potential erosion and sediment delivery remain at the site if it is not decommissioned.

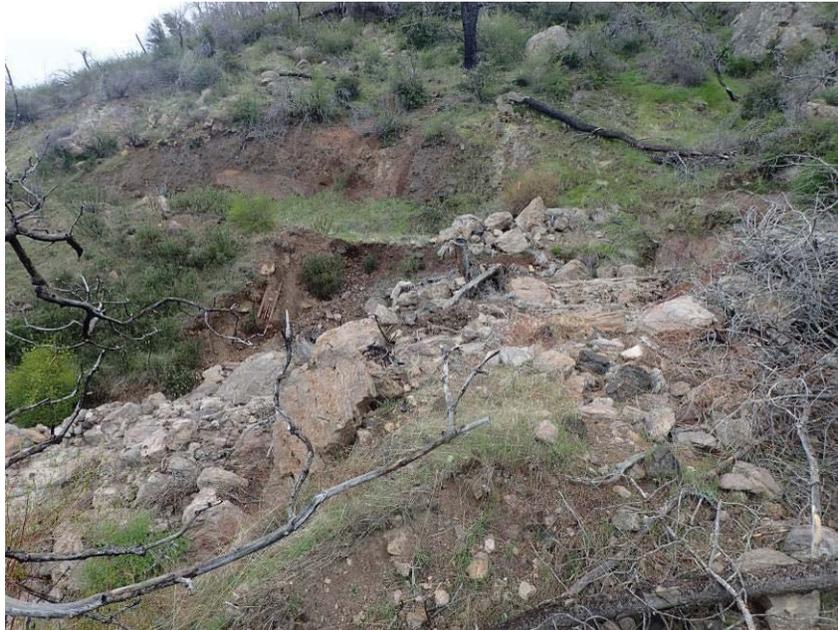
Photo 27. A debris flow with very large boulders washed out Ponderosa Way at Site #53. The original, undersized culvert plugged and failed. The stream diverted down the road, causing hillslope gullies and additional sediment delivery. PWA field crews estimated that 75% of the road prism was washed away by the debris flow.
