**VIDEO WEIR TECHNOLOGY PILOT PROJECT
FINAL PROJECT REPORT
2008– 2010 STEELHEAD ESCAPEMENTS
COTTONWOOD, COW AND BEAR CREEKS,
SHASTA AND TEHAMA COUNTY, CA**

By
Ryan Teubert, Rachel Aschbacher and Mary Mitchell

Western Shasta Resource Conservation District
Anderson, California
October 2011

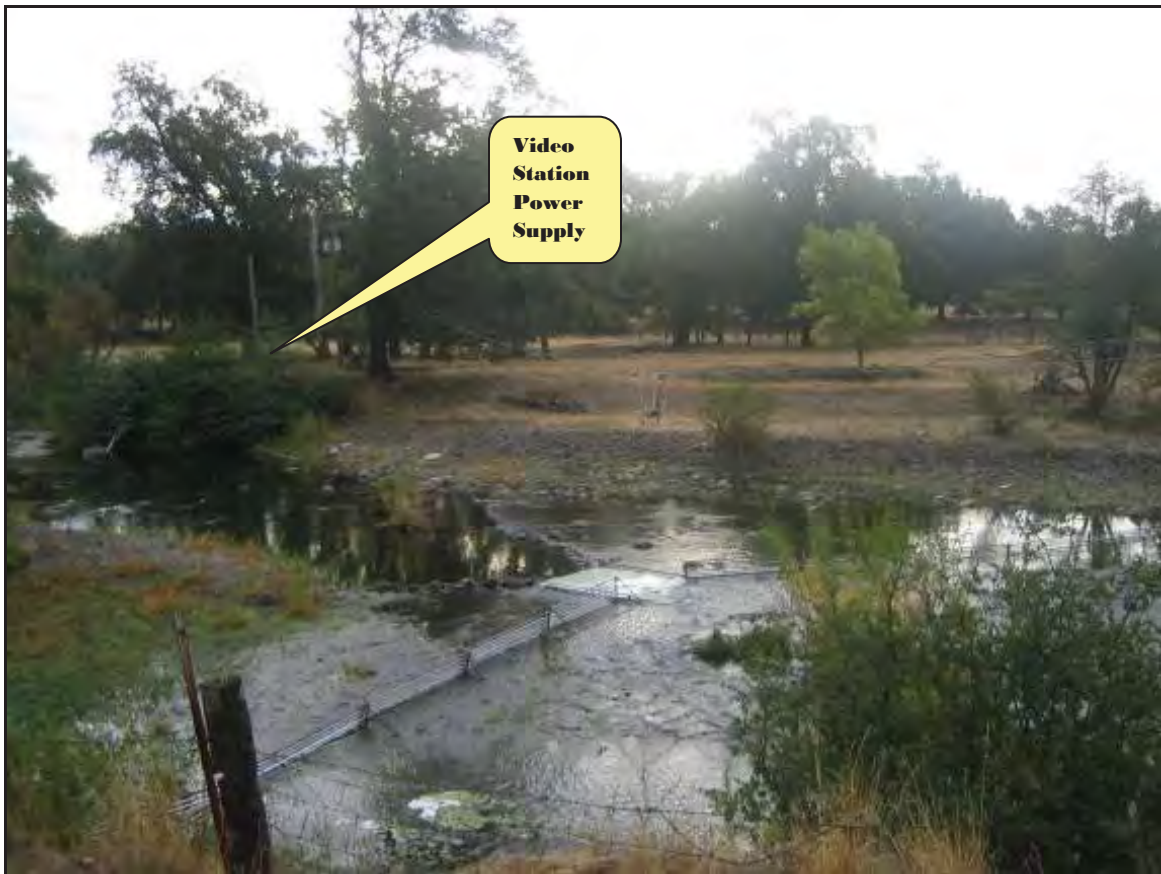
Figure 5. Bear Creek video station power supply box. Cables were used to suspend the camera directly over the weir's fish passage opening. The equipment lock box was located to the right (not shown).

Weatherproof black and white cameras were chosen to provide a high quality image in various lighting conditions. The camera was attached to the outside of a larger box that contained remote lighting and other wiring hookups. The camera box was suspended from two main galvanized steel cables directly over the fish passage opening (Figures 5 and 6). The end of the main cable closest to the DVR-battery box was designed to allow easy movement up and down with a mechanical “come-along” so the camera could be raised or lowered if the lighting needed an adjustment, or if camera cleaning was required. In previous years, the system required a 10 foot ladder to clean the cameras and change the lights.

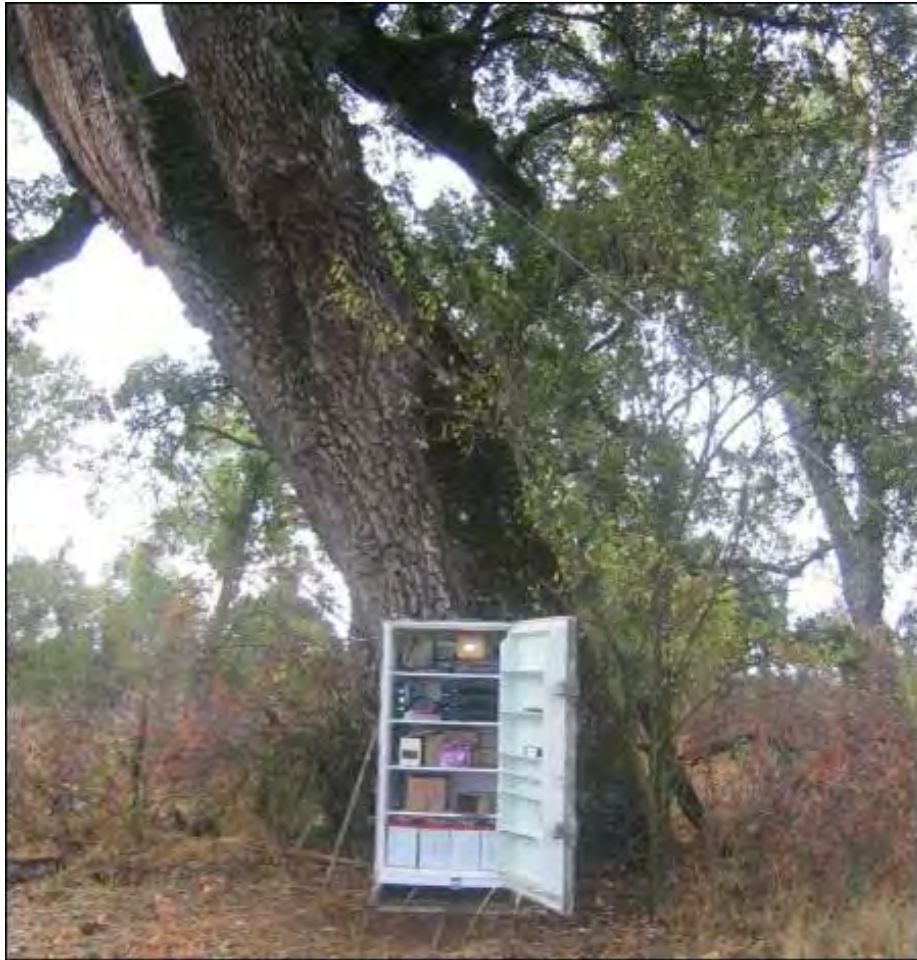
Figure 7. The modified refrigerator contains the DVR's, power controls, equipment and storage boxes, monitor and batteries. The cable above the lock box is the anchoring cable to the two main cables suspending the camera over the creek.

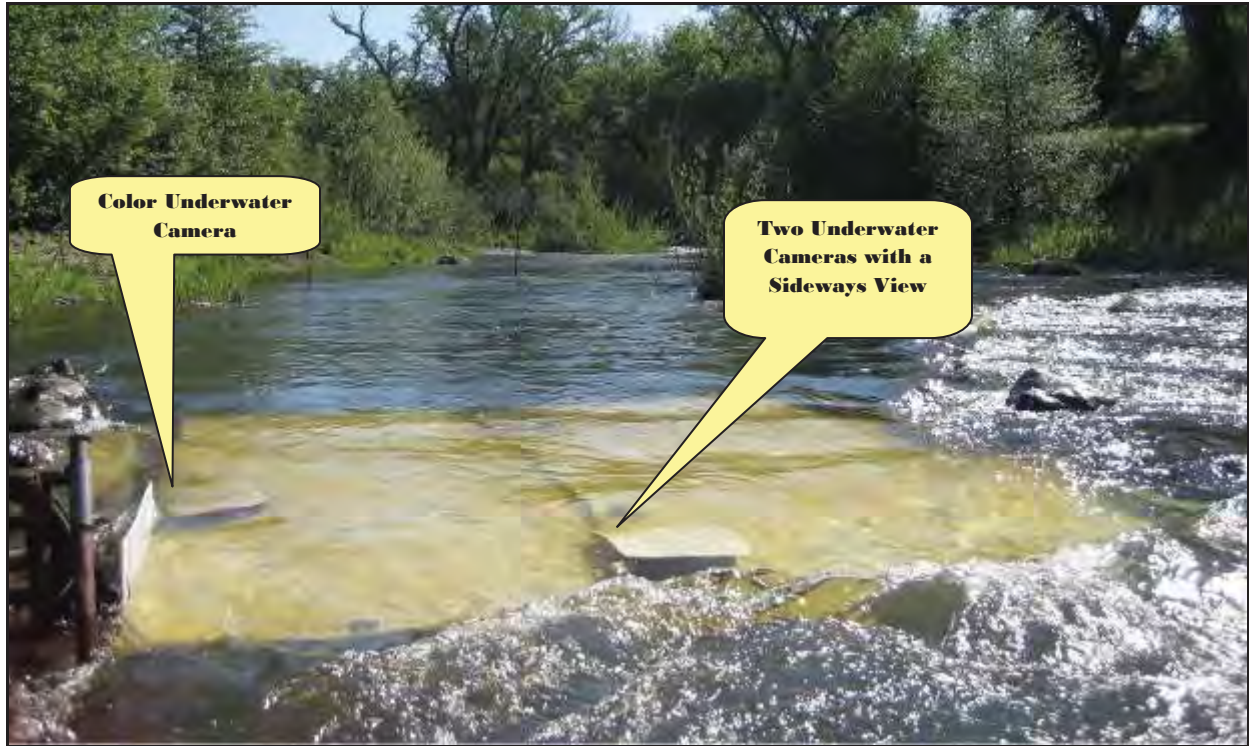
Figure 8. The underwater cameras were useful for monitoring up and downstream movement as well as species identification. The two middle cameras have a sideways view.

The cameras were protected inside a custom-made high grade PVC water-proofed capsule. The capsule was strapped to a 20-pound metal plate that was anchored in the creek bed to withstand any

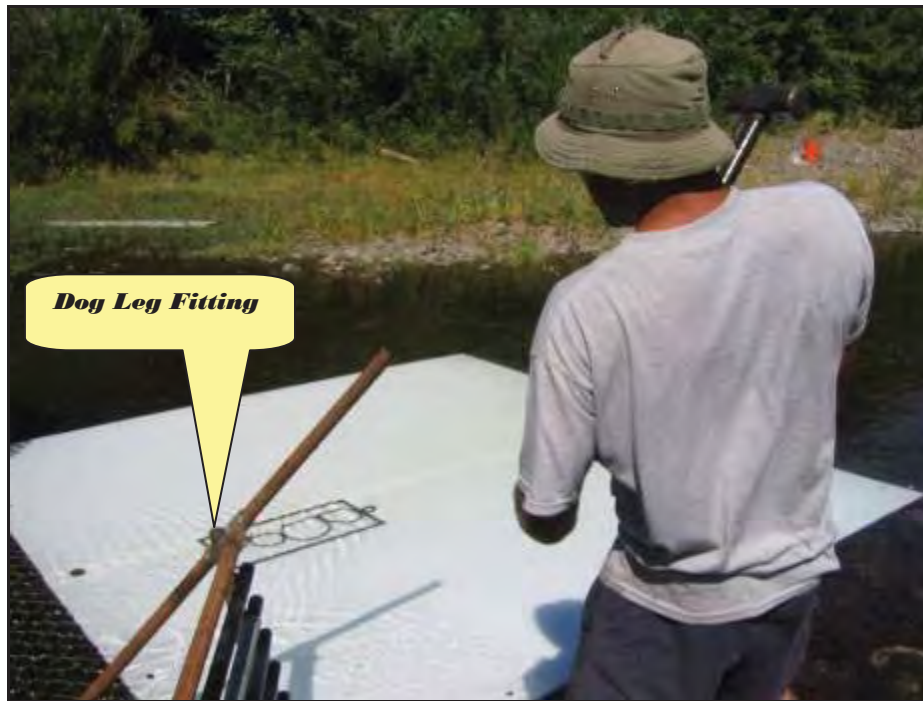
Figure 9. Construction of the weir. Dogleg fittings were bolted to the uprights and the “weir arm” slides through the fitting. This was pounded into the stream bottom at a 45 degree angle downstream.

The dog leg fittings were bolted to the uprights and a “weir arm” was slid through the fitting and pounded into the stream bottom at a 45 degree angle downstream (Figure 9).

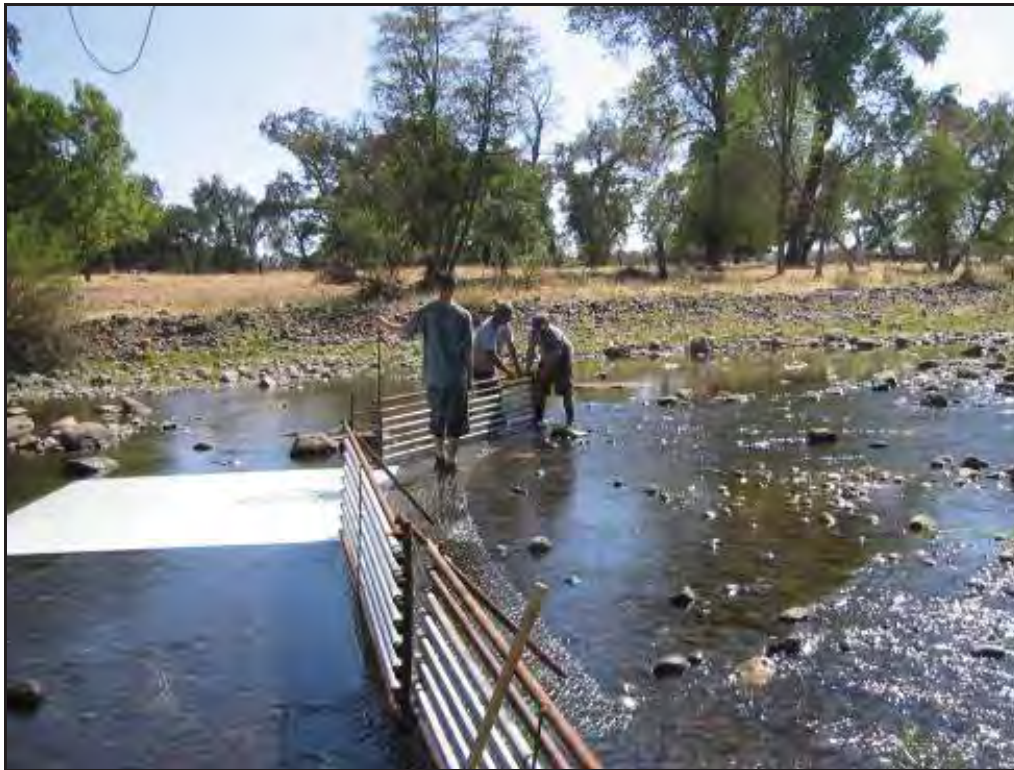
Figure 10. Construction of a weir included white high density polyethylene (HDPE) sheets staked to the creek bottom to make the observation of passing salmon easier.

White high-density polyethylene (HDPE) sheets were staked to the creek bottom below the overhead camera to create a background to improve viewing of the passing fish (Figure 10). The sheets had $\frac{3}{4}$ -inch holes drilled around the perimeters to allow staking and a metal frame plate was bolted to the upstream edge of both sheets prior to placement in the creek. Twenty-four inch concrete form stakes, with a 2-inch washer welded to the top, secured the sheets.

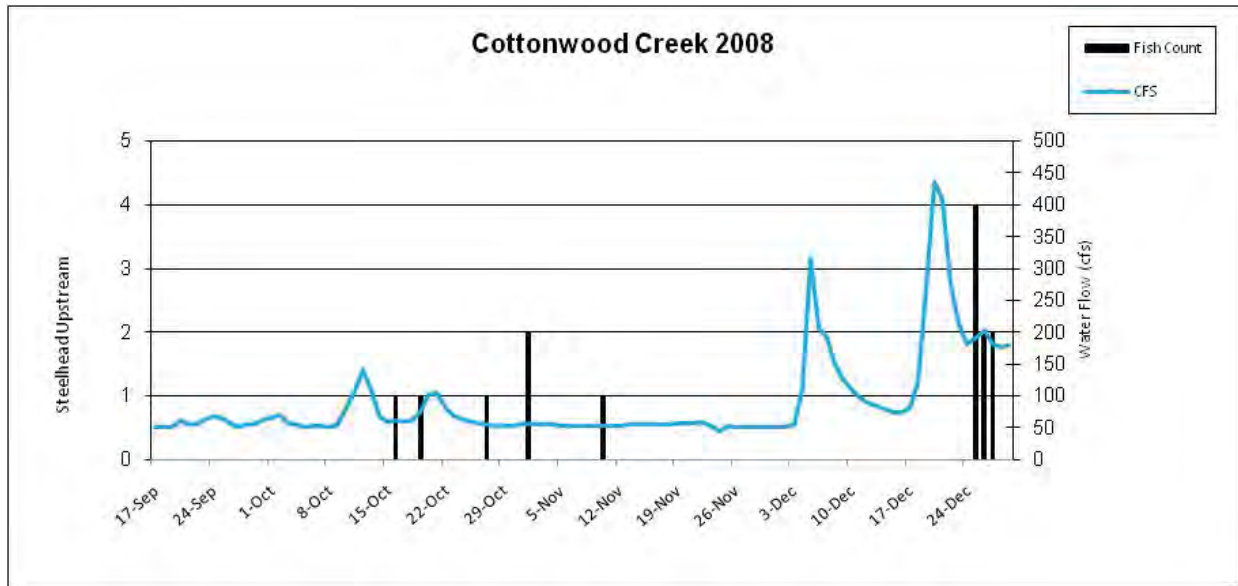
Figure 12. 2008 Total Daily Steelhead Movement vs. Water Flow (cfs); Cottonwood Creek, Shasta County

The video station was operational from September 13 to December 29, 2008. The 2008 final total of Steelhead entering Cottonwood Creek was **14** for the period of the run that was surveyed. The peak day count occurred on December 25, 2008 with 4 fish passing, a mean water temperature (Appendix A) was not available for this date (the thermograph was not operational from December 7, 2008 through the end of the season on December 29, 2008), and a water flow (Appendix B) of 191 cfs. The daily fish passage data and corresponding water flow in cfs are depicted in Figure 12.

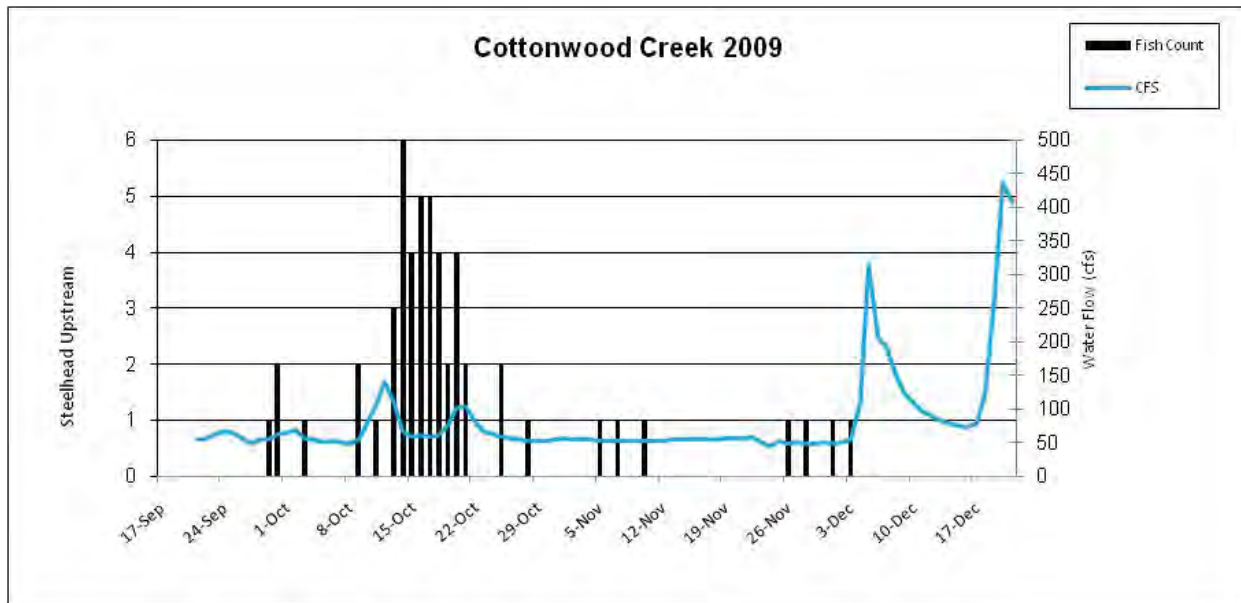
Figure 13. 2009 Total Daily Steelhead Movement vs. Water Flow (cfs); Cottonwood Creek, Shasta County

The video station was operational from September 21 to December 21, 2009. The 2009 final total of Steelhead entering Cottonwood Creek was **52** for the period that the run was surveyed. The peak day count occurred on October 14, 2009 with 6 fish passing, a mean water temperature (Appendix A) of 63.9 (60.5-67.7°F), and a water flow (Appendix B) of 67 cfs. The daily fish passage data and corresponding water flow in cfs are depicted in Figure 13.

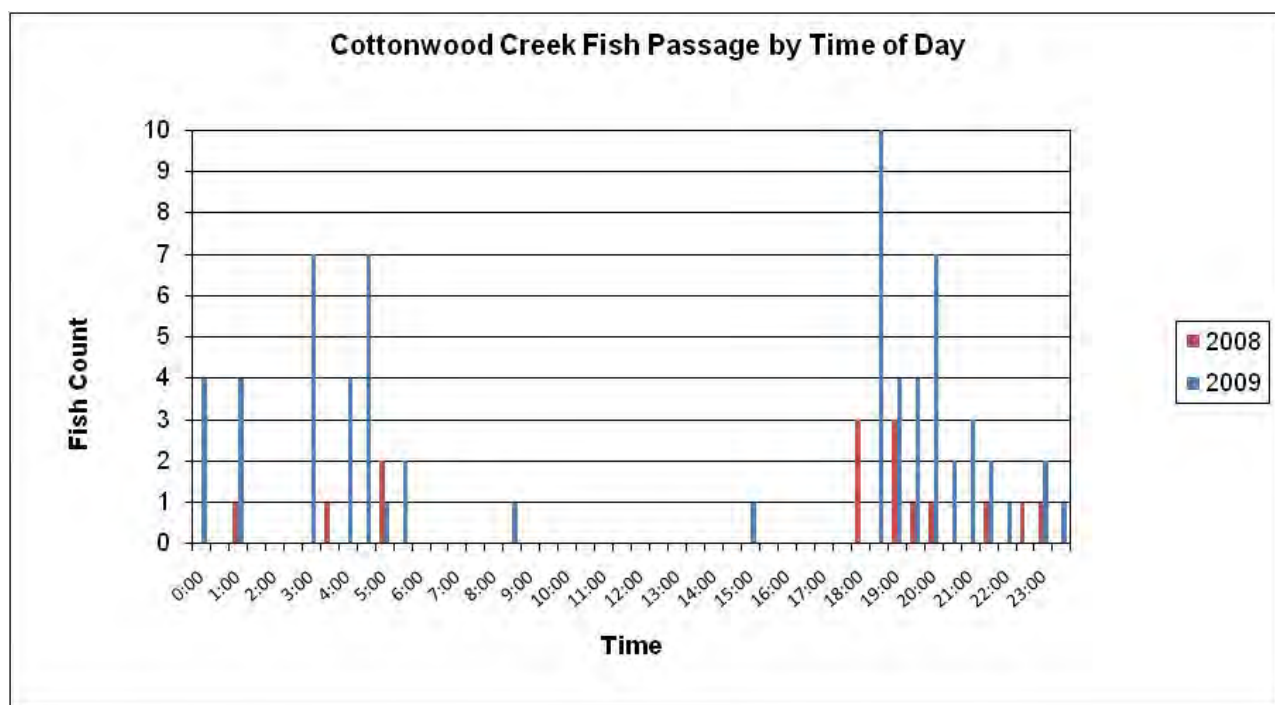
Figure 14. 2008 - 2009 Total Daily Steelhead Movement by Time Of Day; Cottonwood Creek, Shasta County

Because the weir plate was lighted 24 hours per day, a tally of fish movement by time of day was possible as shown by Figure 14. Fish movement by time of day was similar in 2008 and 2009 with fish passage occurring in the early morning and late evening hours. Observations are limited due to the small data set available.

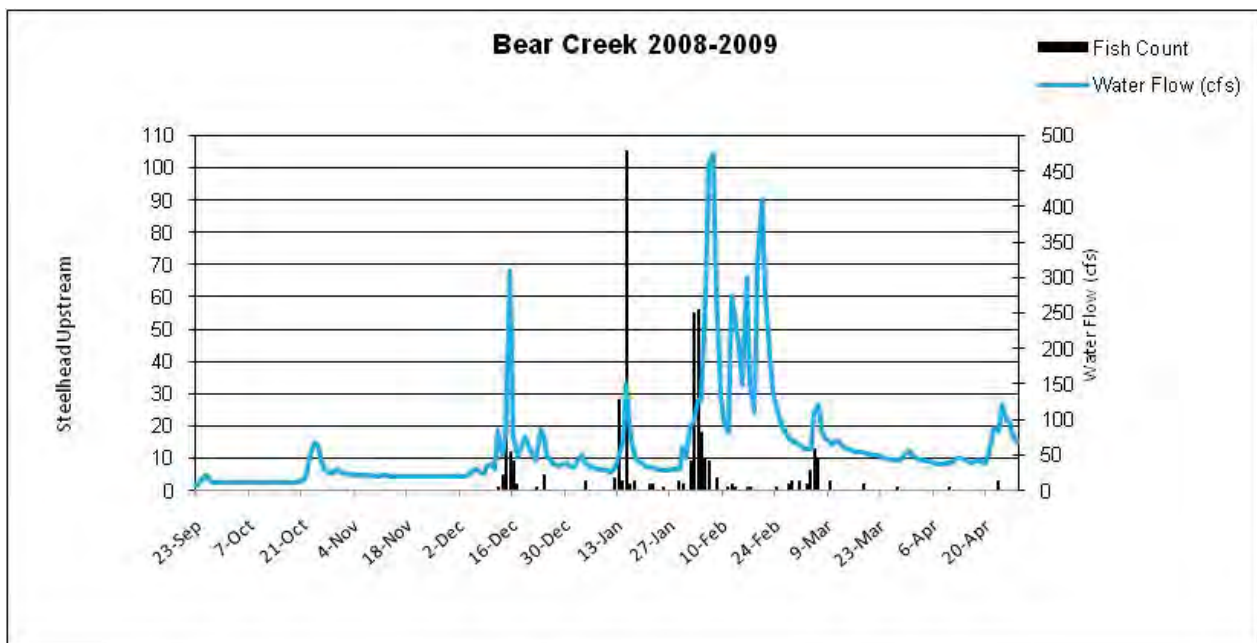
Figure 15. 2008-2009 Total Daily Steelhead Movement vs. Water Flow (cfs); Bear Creek, Shasta County.

This year the video station was maintained through Steelhead season. The video station was operational between September 33, 2008 and May 7, 2009. The 2008-2009 final total of Steelhead that entered Bear Creek was **430** for the season. The peak day count occurred on January 25, 2009 with 105 fish passing; a mean water temperature (Appendix A) was not available for this day due to a thermograph malfunction. The daily fish passage data and corresponding water flow (cfs) (Appendix B) are depicted in Figure 15.

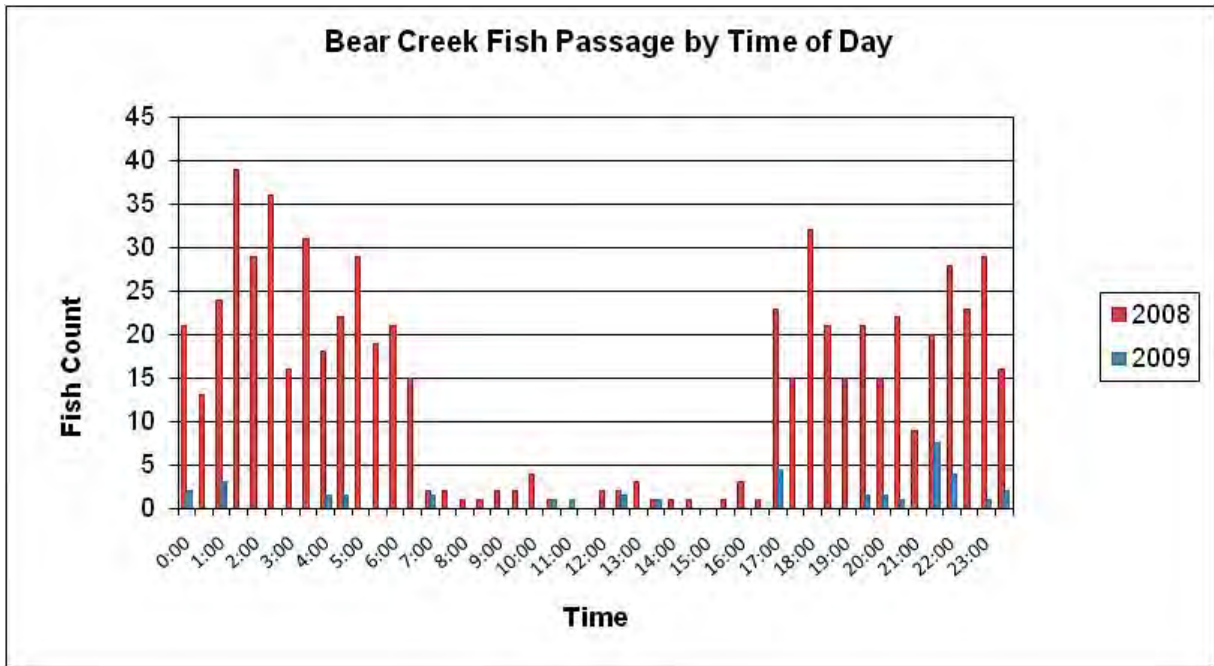
Figure 17. 2008 - 2010 Total Daily Steelhead Movement by Time Of Day; Bear Creek, Shasta County.

Because the weir plate was lighted 24 hours per day, a tally of fish movement by time of day was possible (Figure 17). Fish movement by time of day was similar in 2008 and 2009 with fish passage occurring in the early morning and late evening hours. Observations are limited due to the small data set available.
