**CALFED Bay-Delta Program Project # 97-N07  
FINAL REPORT**

**HYDROLOGY, GEOMORPHOLOGY, AND HISTORIC  
CHANNEL CHANGES OF LOWER COTTONWOOD CREEK,  
SHASTA AND TEHAMA COUNTIES, CALIFORNIA**

**Graham Matthews & Associates  
P.O. Box 1516  
Weaverville, CA 96093**

**November 2003**

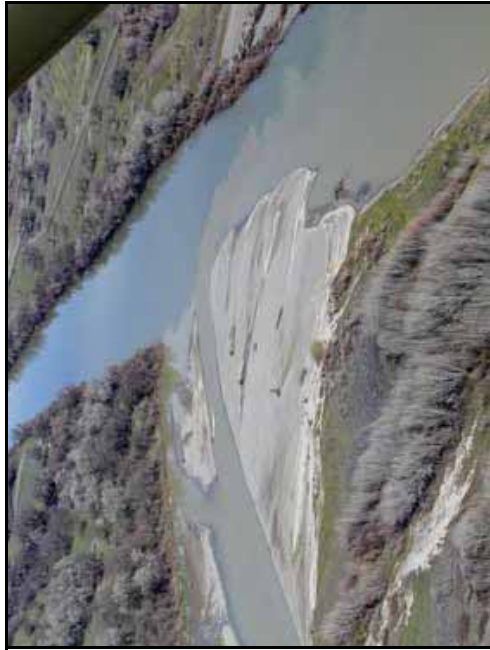
View of the confluence of Cottonwood Creek with the Sacramento River. Note the turbid water from Cottonwood Creek and the pro-gradating delta.

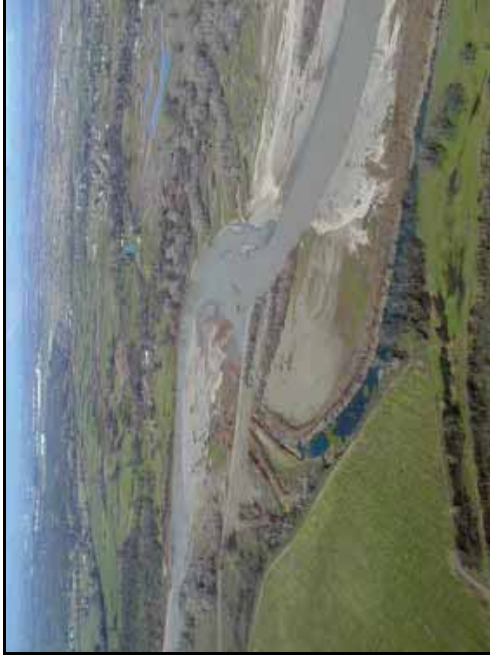
View of Levee constructed in 1998 on the Bengard Ranch, RM 3 to relocate channel and prevent further bank erosion.

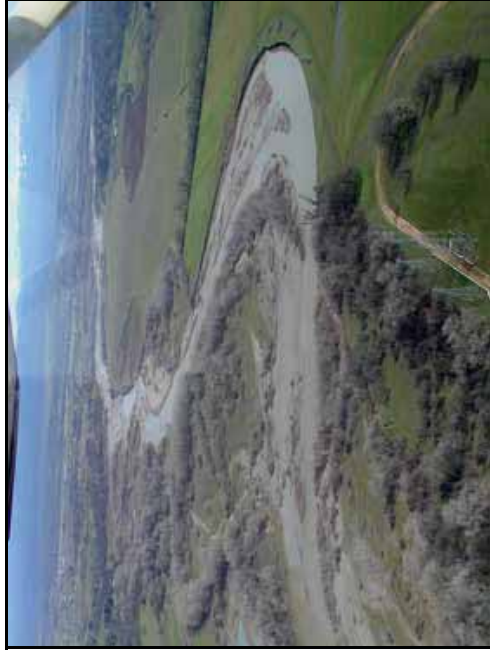
View downstream of large meander migration into pasture. Property Owner has placed concrete rubble from old I-5 bridge in windrows for protection.

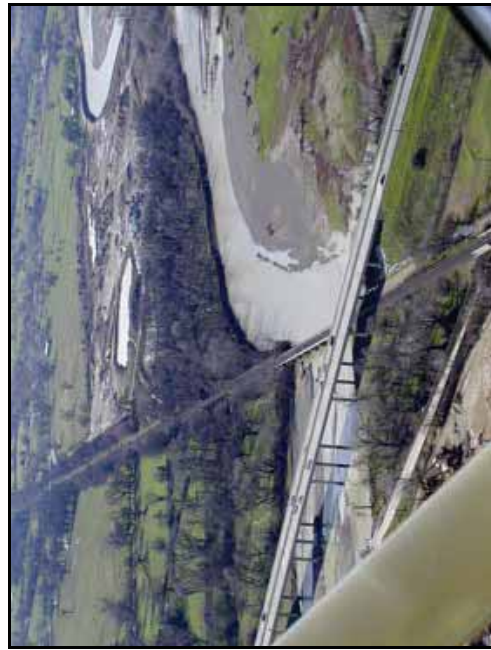
View of bank erosion threatening SPRR just upstream of I-5. Gravel operation is in the background.

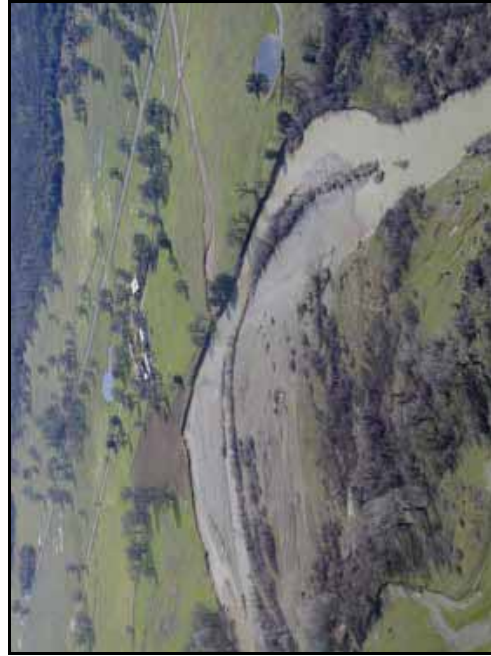
View of Bank Erosion on the Baker Ranch, near the upper end of the study reach.
