United States Department of the Interior

FISH AND WILDLIFE SERVICE
Red Bluff Fish & Wildlife Office
10950 Tyler Road, Red Bluff, California 96080
(530) 527-3043, FAX (530) 529-0292

Re: Increase in fine sediment in South Fork Battle Creek

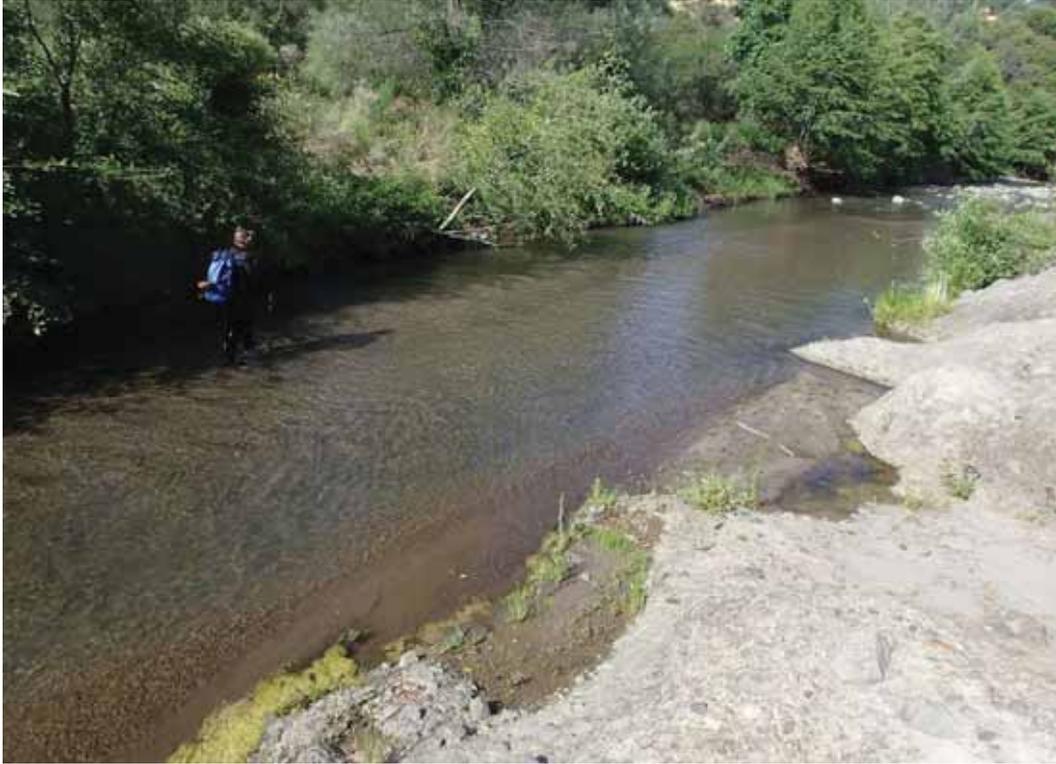
Figure 1: Photograph of historical pool area in Battle Creek Reach 3 filled with sand taken June 5, 2015. This area prior to 2015 was approximately 2-4 ft. deep at comparable stream discharge and contained cobble substrates.

On June 5, 2015, a snorkel survey of Battle Creek, Reach 3 (the South Fork of Battle Creek from Coleman Diversion Dam to North Fork/ South Fork [NF/SF] Battle Creek Confluence) intended to observe and document the locations of live adult chinook salmon was conducted by three Red Bluff Fish and Wildlife Office (RBFWO) employees. One adult chinook salmon was observed during this survey. Observations were made during this survey that there appeared to be a large influx of fine sediments throughout Reach 3. These employees have conducted surveys in this reach for multiple years prior to 2015 and have experience and knowledge with the historical conditions of this section of the creek, typical sediment sizes, and typical areas in which chinook salmon redds are observed. In comparison to conditions prior to 2015, they observed that: 1) holding pools, historic areas of chinook salmon spawning, and interstitial spaces between larger rock substrates had been filled in or blanketed with a layer of sand 2) anecdotally, there was a great reduction in the number of smaller fish (e.g. rainbow trout, riffle sculpin, Sacramento suckers, etc.) and invertebrates observed during the survey, and 3) temperature loggers located at three points in Reach 3 had been buried by sand requiring considerable effort to extract them for download. The employees documented their observations photographically (fig. 1) and immediately reported their perceived change in conditions via e-mail to superiors.

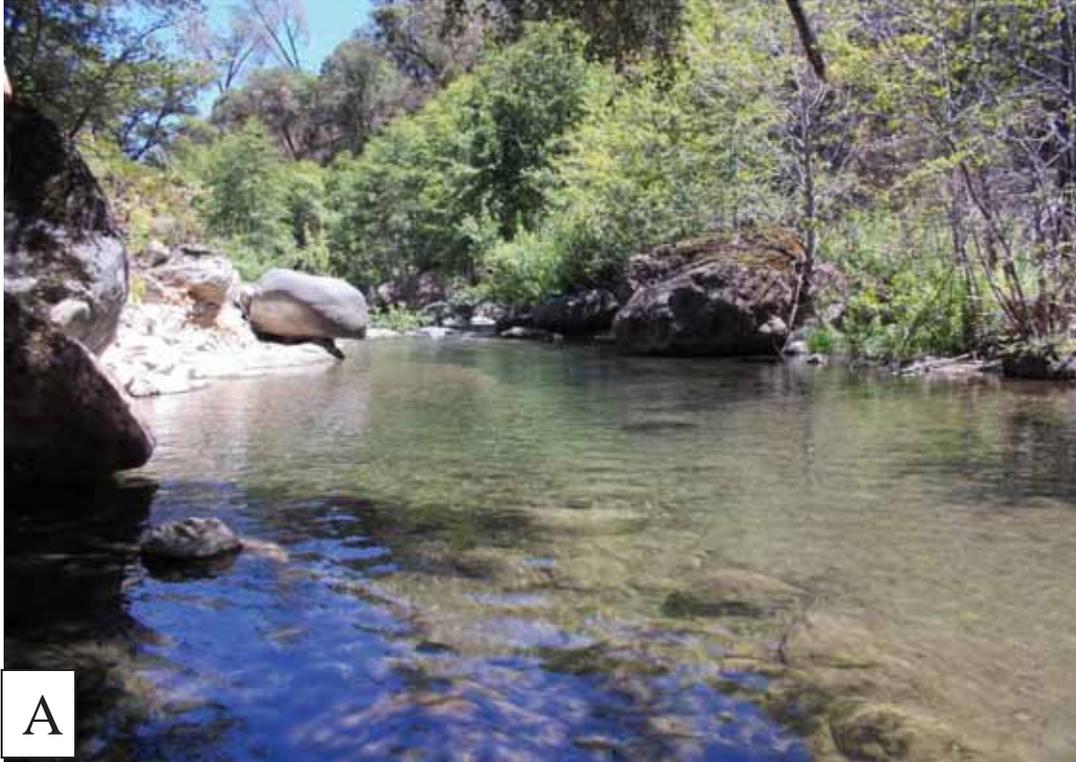
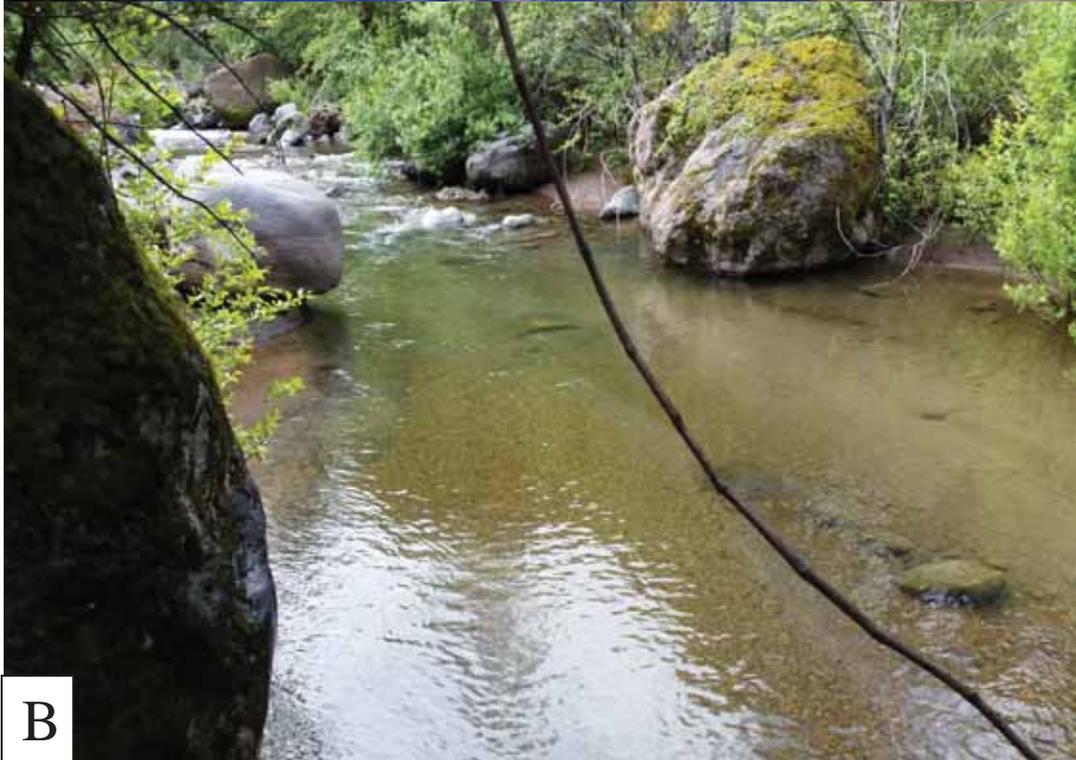
Figure 3(A&B): Photograph of South Dam temperature logger location taken A) 7-9-2013 and B) 6-10-2015 from a comparable location.

The South Dam temperature logger is located less than a half mile downstream of the dam (Lat 40.3693/ Long -121.8010) in a portion of Battle Creek that historically was a moderately deep pool, approximately 2-4 ft. deep in the center (fig. 3A). This area was observed to have been filled with sand (fig. 3B); the employee was unable to extract and download loggers due to depth of sand burying the loggers. A nearby temperature logger located at the origin of the South Dam Canal (Lat 40.3692/ Long -121.7897) was also found to be deeply buried in sand within the canal. The South Dam Canal has been off-line since December 3, 2014, which is the date of the high flow event associated with high precipitation in the Battle Creek watershed. This is corroborated by temperature data downloaded from the South Dam Canal temperature loggers (fig. 4) which shows an alteration in the profile of the thermograph at 12-3-2014 18:30 changing to a smooth line in contrast to the typically diel temperature curve of a properly functioning temperature logger, indicative of the loggers being buried in sand and not accurately reading water temperature. A section of the South Dam Canal flume collapsed in the Devil's Gulch area of the watershed (fig. 2) resulting in a torrent of water and extreme erosion, which washed out the access road to South Dam and washed a large amount of sediment into the creek downstream

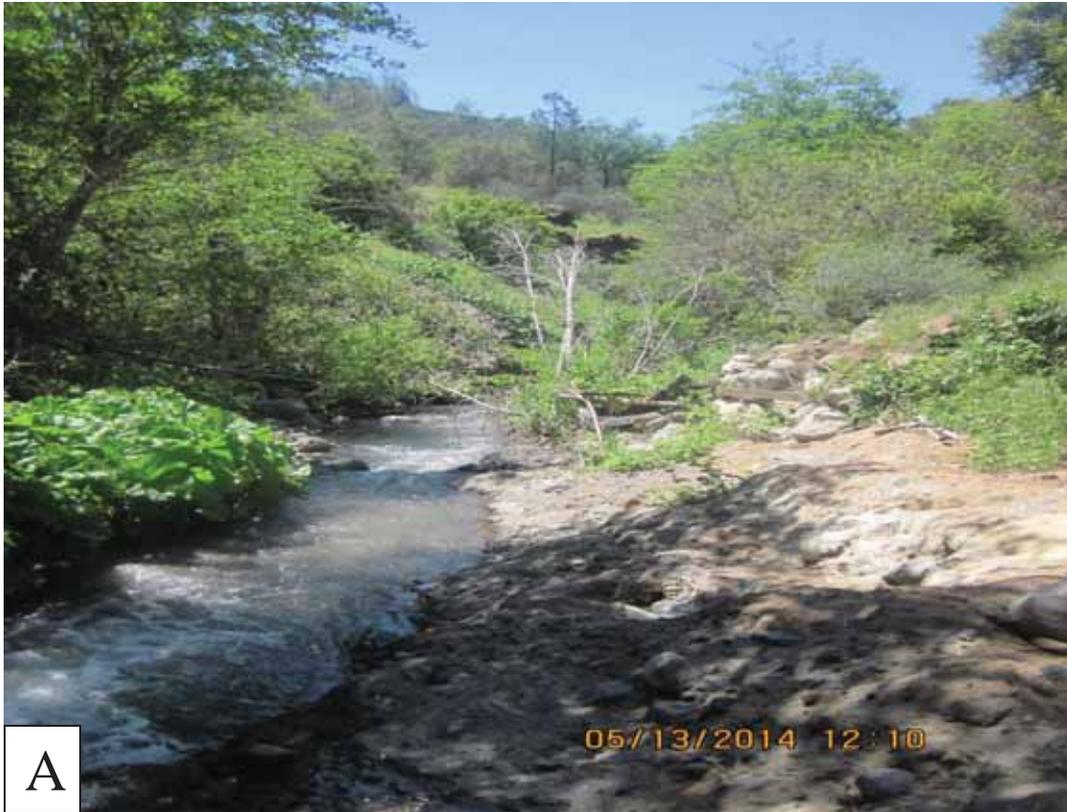
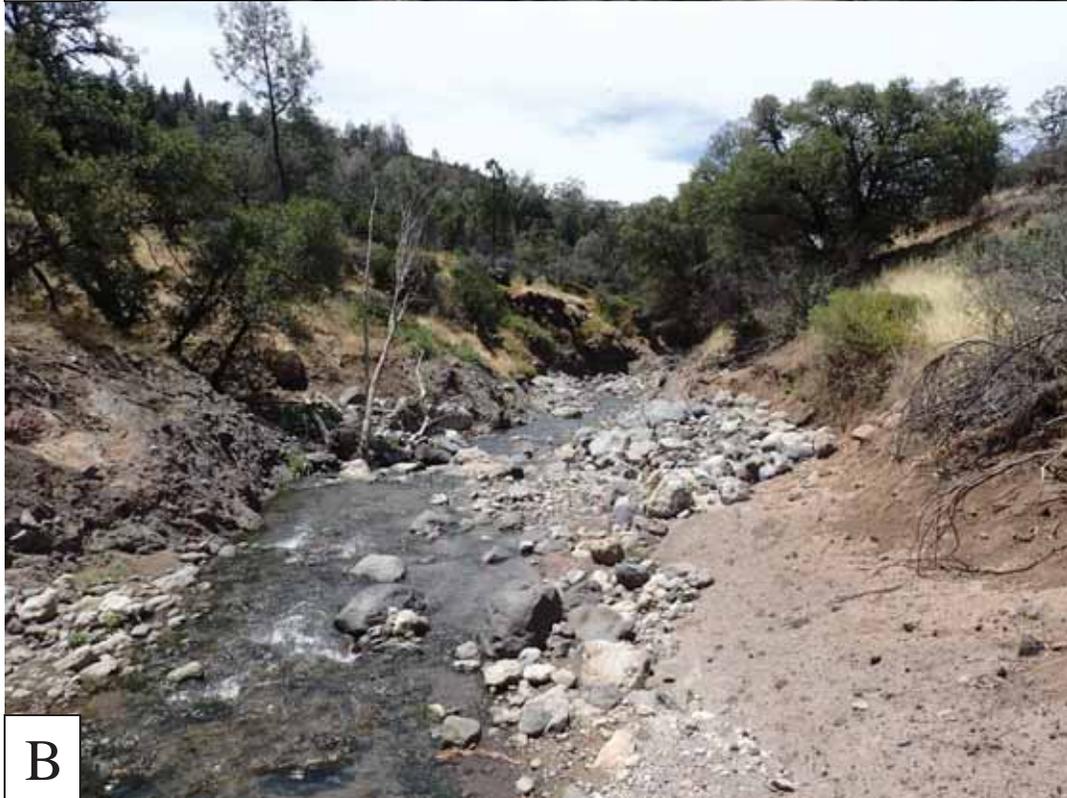
Figure 6(A&B): Photograph of Soap Creek temperature logger location taken A) 5-13-2014 and B) 7-13-2015 from a comparable location while facing downstream.

Downstream from South Dam is the confluence of Soap Creek with SF Battle Creek. Temperature loggers are located in Soap Creek approximately 1 mi upstream from the confluence with Battle Creek and two other locations a short distance upstream and another downstream of the confluence in SF Battle Creek. On July 13, an RBFWO employee visited soap creek to photographically document changes to the riparian area associated with high flows during winter 2014/2015. Large trees and understory vegetation have been lost in the riparian area in addition to a dramatic erosion of soils revealing an underlying layer of sedimentary bedrock (fig. 6 A&B). Additionally, an influx of fine sediment was seen in the stream channel resulting in a reduction of depth of pools and runs within Soap Creek (fig. 7 A&B). Similar effects were seen in the area of Bluff Springs on July 9, although it was not documented photographically. Debris created from the loss of riparian vegetation was observed throughout the Soap Creek basin, primarily congregated around structures associated with the Soap Creek Canal system (fig. 8). The Soap Creek Canal system sustained considerable damage as a result of high discharge and debris loads including, but not limited to, damage to metal flumes, loss of walkways adjacent to canal due to erosion of substrate supporting the base of walkways, and damage to gates and other structures of Soap Creek Canal Diversion Dam. The Soap Creek Canal is still functional despite damage, and there is evidence of work in progress to repair the damage in the form of tools left in the area of damaged sites (e.g. pry bars, “come-alongs”, sledge hammers, etc). The area just downstream of the Below Soap Creek/ SF Battle Creek Confluence temperature logger location was photographed May 13, 2014, when the logger was deployed (fig. 9A) and again July 13, 2015 (fig. 9B). From these photographs, you can see a difference in the amount of sand in the creek as well as a reduction in the riparian vegetation on river left. The course of the stream channel has been altered and now runs through an area which previously contained riparian vegetation (fig. 9B, upper left corner). The influx of fine sediment has resulted in a narrowing and reduction of depth in the stream channel.

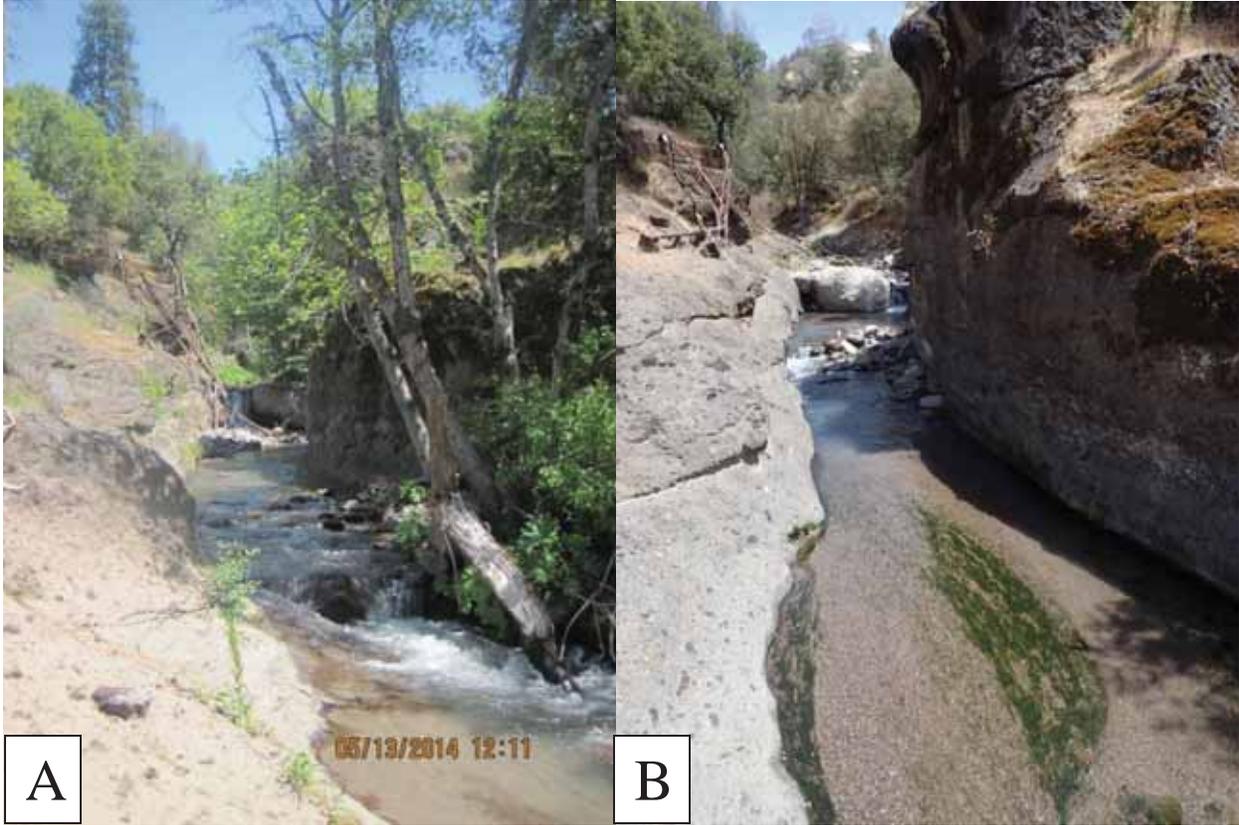
Figure 7(A&B): Photograph of Soap Creek temperature logger location taken A) 5-13-2014 and B) 7-13-2015 from a comparable location while facing upstream.

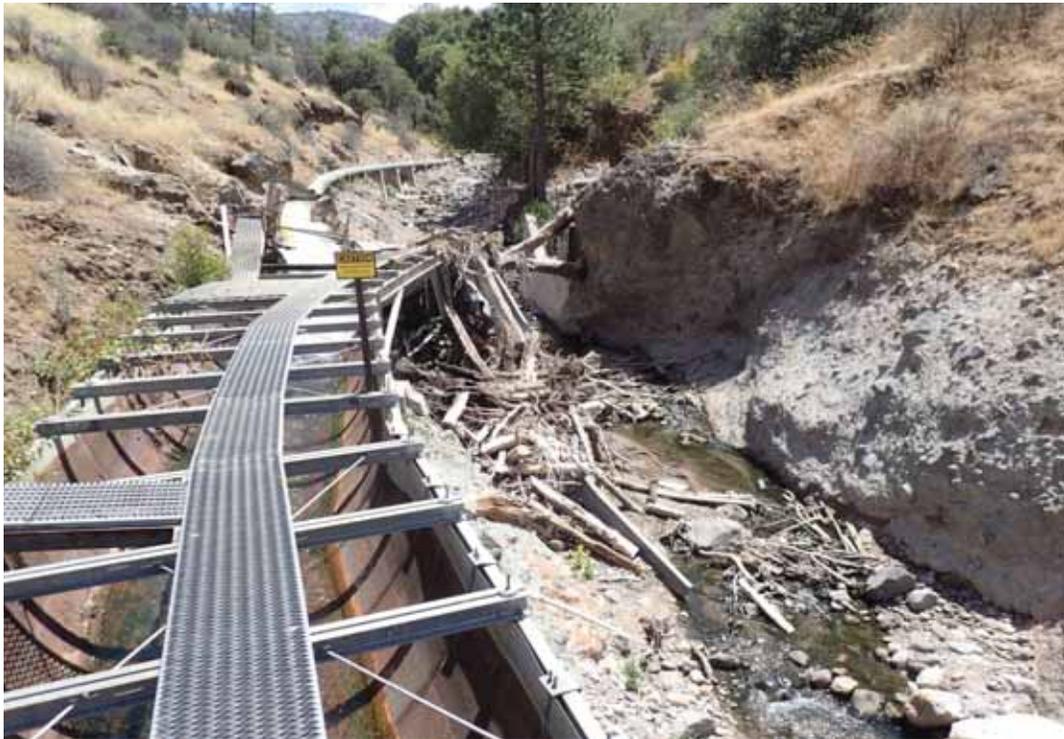
Figure 8: Photograph of Soap Creek Canal and debris associated with riparian vegetation loss in the area. Difference in elevation between walkway atop canal and stream bed is approximately 15 ft.

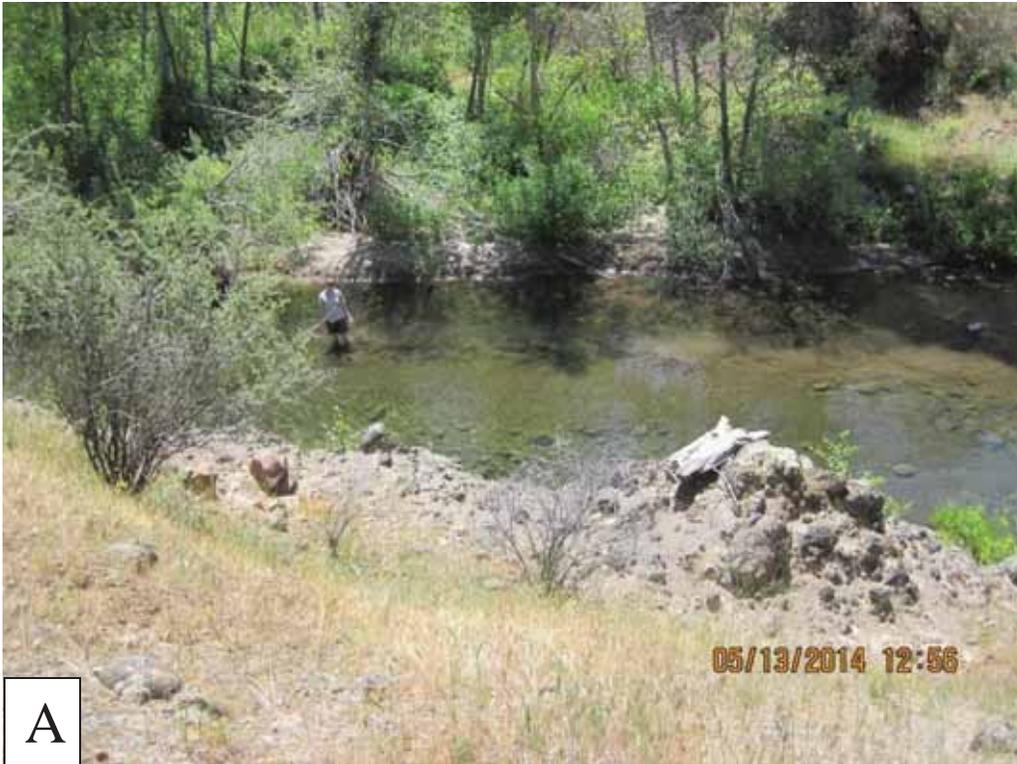
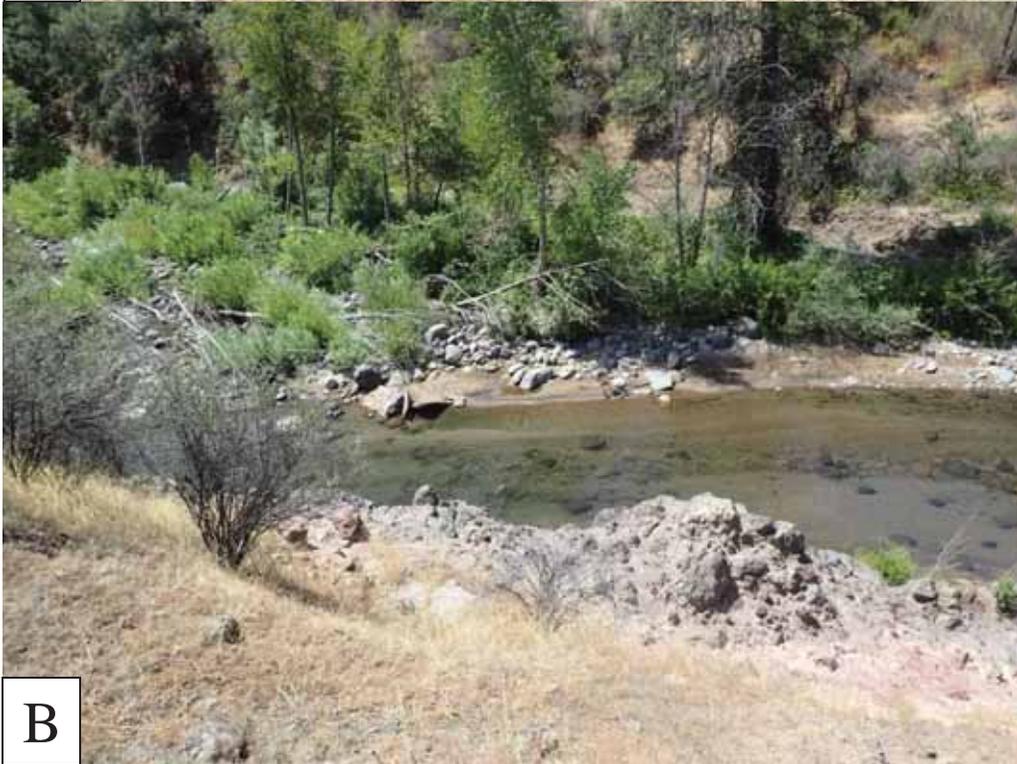
Figure 9(A&B): Photograph of area near Below Soap Creek temperature logger location taken A) 5-13-2014 and B) 7-13-2015 from a comparable location.

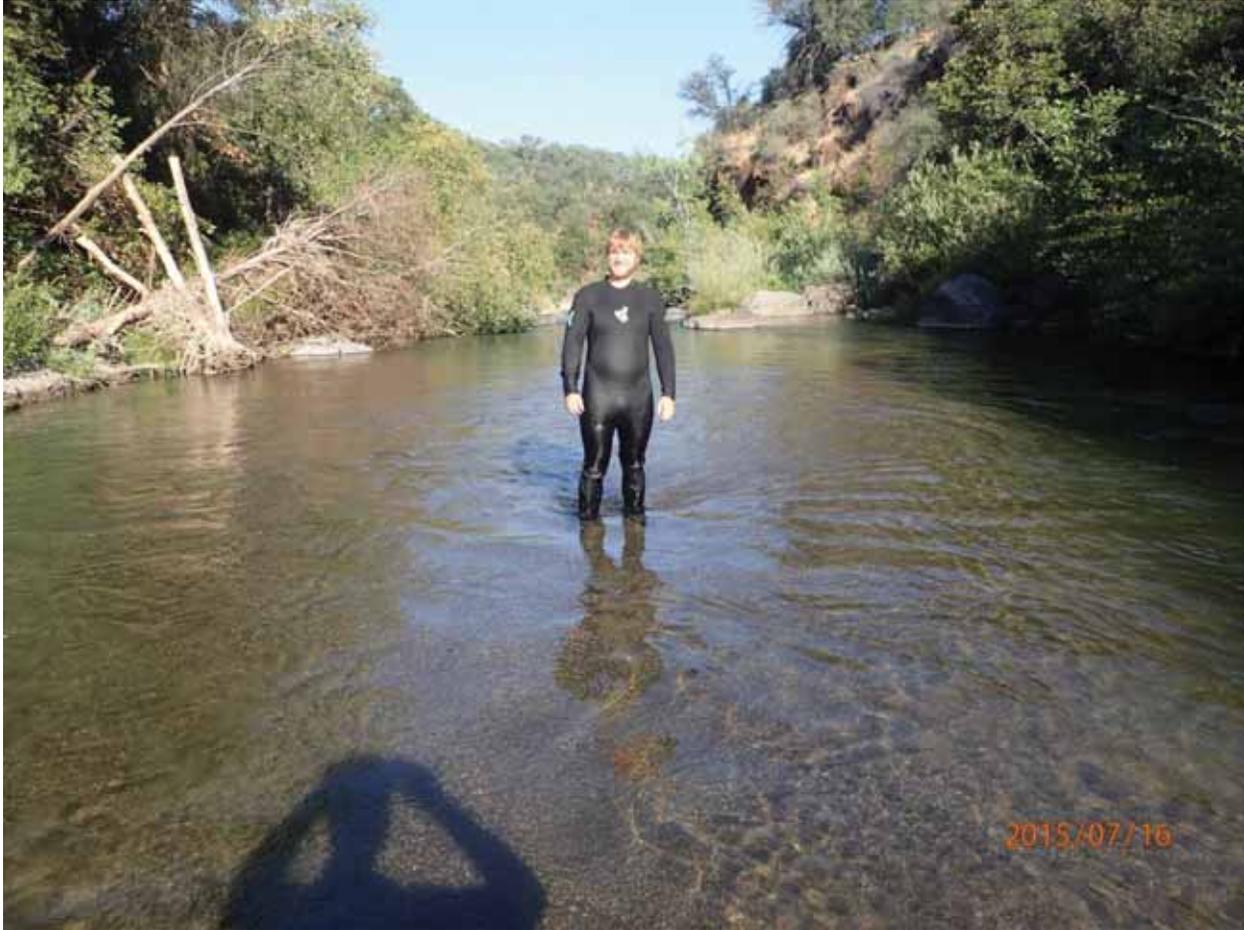
Figure 10: Area immediately below NF/ SF Battle Creek confluence, which historically has been a pool habitat. RBFWO employee is illustrating current depth of water in area. (no pre-2015 picture available for comparison)

currently >1 ft. deep (fig. 10), making it unsuitable for use by chinook salmon as a holding pool. The sediment here is very loosely packed, and when walked upon causes one to sink deeply into the sand. Further downstream in Reach 4 below the confluence of Baldwin Creek (adjacent to Darrah Springs State Fish Hatchery), is an area known as Baldwin Pool (fig. 11A&B) which historically is a major holding pool for adult chinook salmon. Although adequate pool habitat still exists around the perimeter of the pool, a large mound of sand is present in the middle of the pool. This area historically has been a deep pool, >10 ft deep in the center; however the volume of the pool has now been greatly reduced due to the influx of fine sediment. The effects of this fine sediment were observed to be considerable for the first two-thirds of the span of Reach 4, with the observed effects reduced for the last third of the reach. No adult chinook salmon were observed in either the NF or the SF of Battle Creek during snorkel surveys. In Reach 4 on the mainstem, approximately 25 chinook salmon were observed in Baldwin Pool. Baldwin pool is typically surveyed by one RBFWO employee observing from the high vantage point, as seen in figure 11, wearing polarized glasses while two other employees snorkel through the pool area. A large number of non-target fish species, such as Sacramento suckers and Sacramento pike minnow, were also observed in Baldwin pool during the observation making a completely accurate count of chinook difficult, although survey members were confident in their approximation. No other chinook salmon were in Reach 4 aside from those in Baldwin Pool.

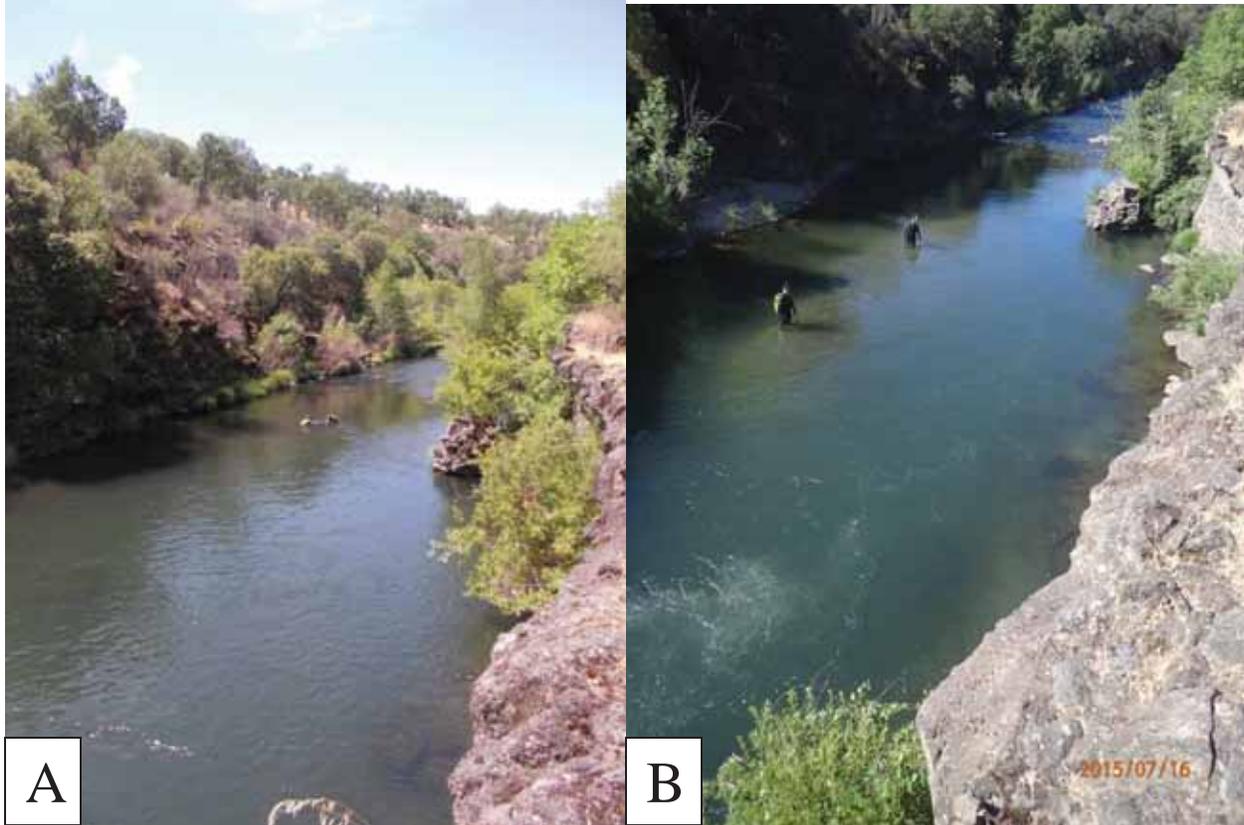
Figure 11(A&B): Photograph of Baldwin pool taken A) 7-26-2012 and B) 7-16-2015 from a comparable location. RBFWO employees are illustrating depth of pool by standing atop a mound of sand.

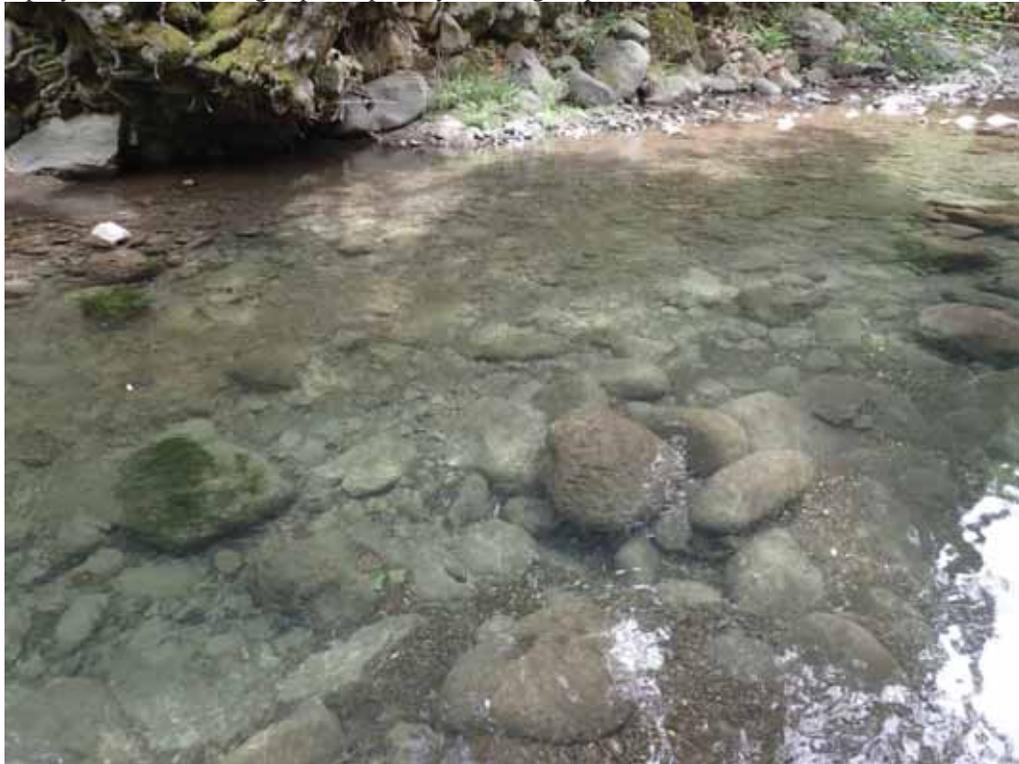
Figure 12: Photograph of SF Battle Creek near confluence of Panther Creek taken 7-16-2015 showing stream substrate and lack of influx of sandy sediments (no pre-2015 picture available for comparison).

In conclusion, a large influx of sediment has been observed in SF Battle Creek presumably originating from the area of the Ponderosa fire in the SF Battle Creek watershed. Areas in SF Battle Creek upstream of the influence of the fire, such as SF Battle Creek near the confluence of Panther Creek (Lat 40-3567/ Long -121.7298), have no observable increase in the presence of fine sediments compared to conditions prior to 2015 (fig. 12). Also, NF Battle Creek in the reaches we regularly survey has no observable increase in the amount of fine sediments compared to conditions prior to 2015. The mainstem of Battle Creek shows a marked increase in the amount of fine sediment in the upper portion near the confluence with SF Battle Creek, with this influence gradually decreasing with distance downstream. Tributaries of SF Battle Creek, such as Soap Creek and Bluff Springs, in the area of the watershed effected by the Ponderosa Fire show evidence of riparian vegetation loss, scouring of riparian sediments, and an increase in instream fine sediment. Observations and quantitative investigations by RBFWO are currently underway with further actions planned to document this increase of sediments in the future.
