Tehama County Resource Conservation District

# WUI and Watershed Protection / Emergency Access Assessment (Coleman Fish Hatchery Road and Ponderosa Way)

Final Report, including background, public outreach, fuels and roadway assessments, GIS methodology, photographic galleries, field notes, and recommended future projects together with funding strategies.

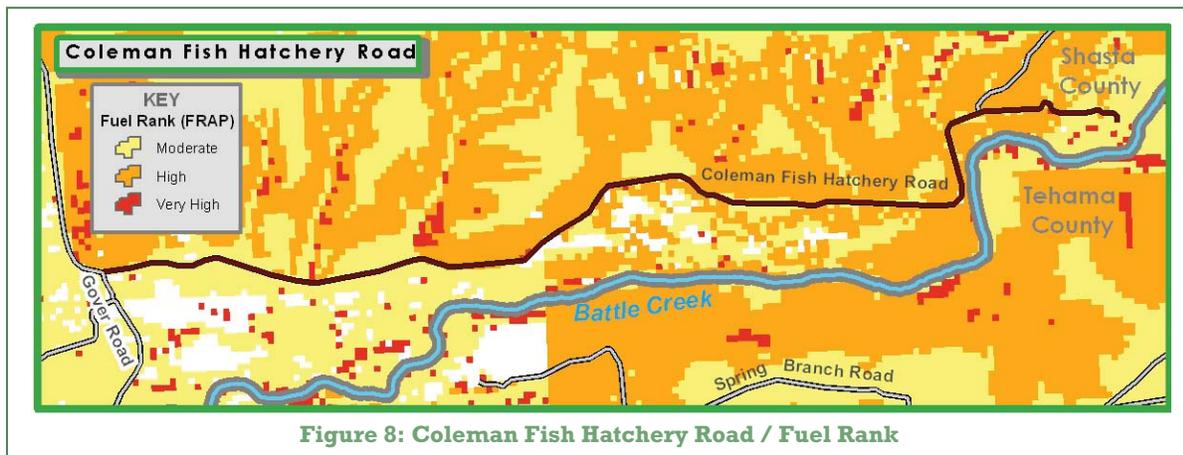
Figure 8: Coleman Fish Hatchery Road / Fuel Rank

*Fuel Conditions along the Roadway.* For use by state citizens and public agencies pursuant to the California Fire Plan, CalFire has created a GIS dataset showing fuel rank that indicates “moderate, high and very high fuel rankings based on inputs, such as fuel, slope, brush density (ladder), and tree density(crown cover)(CalFire, 2005). Because the scale of this dataset is based on a 30-square meter cell, it can only be considered as generalized information for the 3.5-mile length of Coleman Fish Hatchery Road, together with the fact that fuel conditions change from year to year and between dry and wet years. Notwithstanding this, Figure 8 assists in gaining an understanding of the fuel conditions along Coleman Fish Hatchery Road.

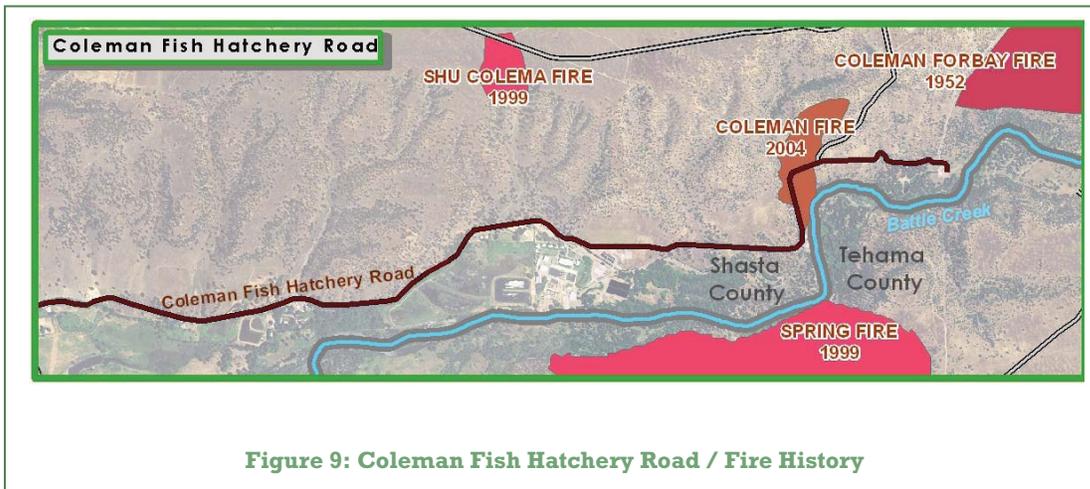
A second GIS dataset containing historic fire perimeters is also available for public use from CalFire and is included in

Figure 9 below for Coleman Fish Hatchery Road. It is wise to note that this dataset contains most known fires but, of course, cannot include every small grass fire that occurs. Coleman Fish Hatchery Road is especially vulnerable to grassland fires due to the characteristics of its surrounding landscape. The dataset does include four fires that occurred near the roadway in 1952, 1999, and 2004.

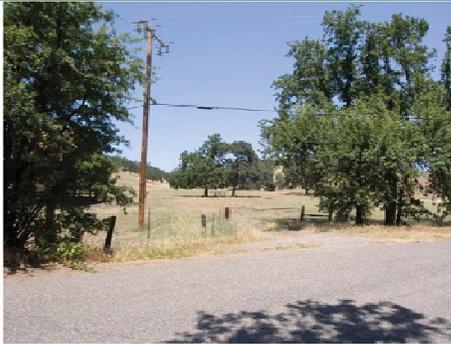
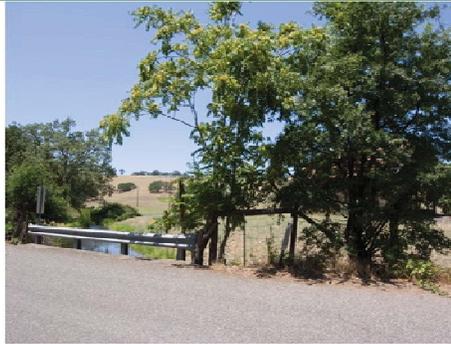
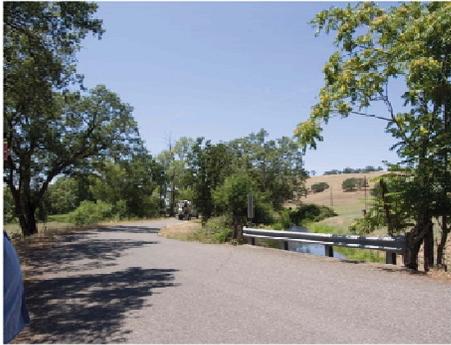
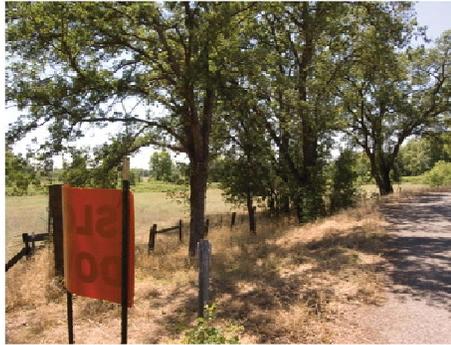
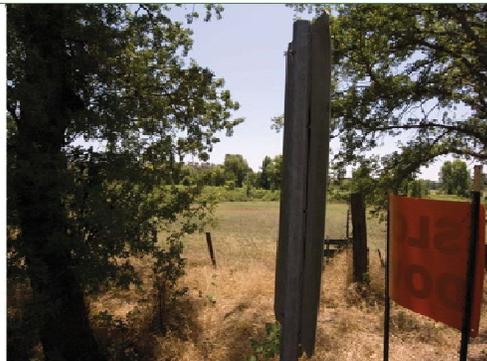
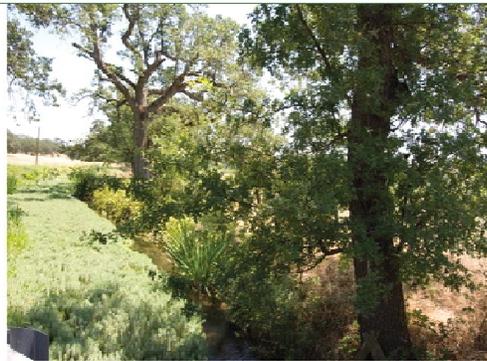
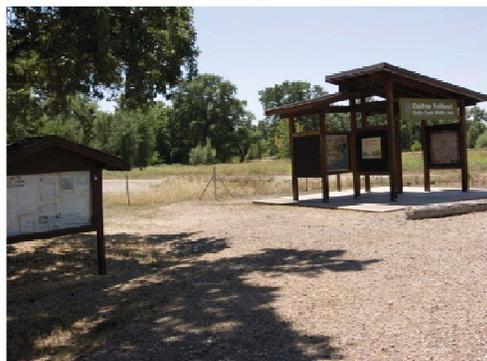
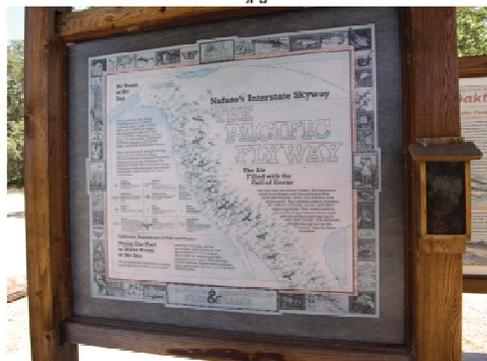
TCRCD staff drove the length of Coleman Fish Hatchery Road on June 26, 2009. The photographs taken on that visit are shown below, beginning at the junction with Gover Road, passing by the Battle Creek Wildlife Area, and ending at the Coleman National Fish Hatchery facilities. These photographs show that there is some need for removing low-hanging branches on roadside vegetation as a best management practice but that for the most part the roadway is bordered only by grasslands. There is also ample clearance for passage of emergency vehicles such as fire trucks.

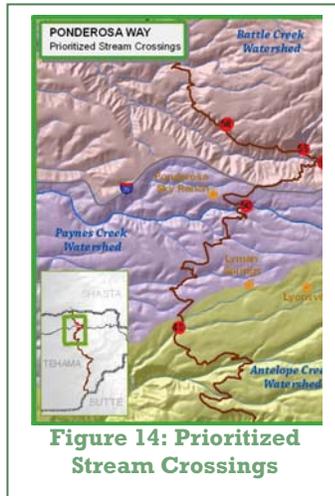
**Figure 14: Prioritized Stream Crossings**

In a simple vector overlay analysis, the above seven datasets were combined geospatially, and their values were added together into a new shapefile. This resulted in numerically ranked polygons with values in four classes grouped in the following ranges: from 0 to 7, between 10 and 19 (for Secondary WUI locations), between 20 and 29 (for Primary WUI), and greater than or equal to 30 (for Urban WUI).

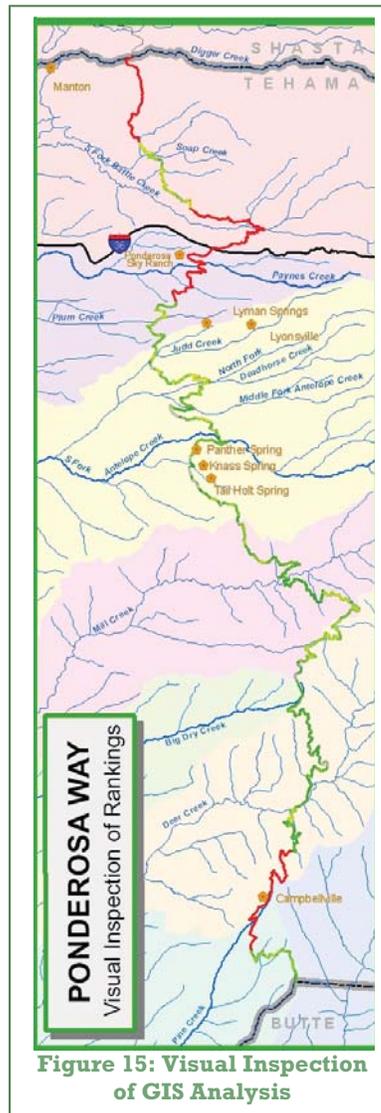
**Figure 15: Visual Inspection of GIS Analysis**

For the other ranked classes that accounted for proximity to WUI areas, it is informative to make a visual examination of the rankings along the entire length of the roadway within Tehama County. In Figure 15, the 200-foot buffer of Ponderosa Way has been filled with the numerically ranked polygons resulting from the vector overlay analysis. The polygons have been assigned a color ramp from green to orange to red, with all values of 7 and above being given the color red. This technique provides a quick visual display of the numerically ranked polygons along the entire length of Ponderosa Way from the northern border of Tehama County to the Butte County line, without regard to the 66 focused stream crossings. As one might logically expect, the red-colored segments of the roadway are concentrated near the Manton urban area, near Highway 36, and near the community of Campbellville, where developed urban areas are found and where the WUI values have increased the ranking values. However, as an additional insight, black haloed areas have been

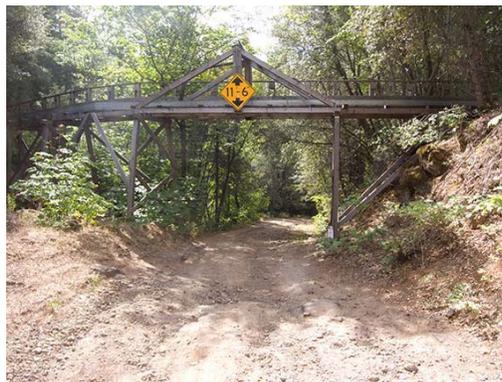
(i) Site 73. An 11'3" high overhead flume crosses Ponderosa Way at this location. In discussions with CalFire and US Forest Service fire personnel, the crossing height is sufficient for both state and federal fire engines. However, oversized water tenders and truck/trailer combinations hauling dozers would probably not be able to pass under the structure. It was mentioned that with the construction of a new CalFire station on Manton Road to the west of Ponderosa Way, oversized equipment can take alternative routes around this crossing.

Nevertheless, if equipment arrives on the wrong side of the flume, it would take a considerable amount of time to back up, return to Manton, and take another route in the opposite direction. This could be of particular importance in the event out-of-area crews

respond to a wildfire or if dispatchers are given a fire location that is actually on the opposite side of the structure.

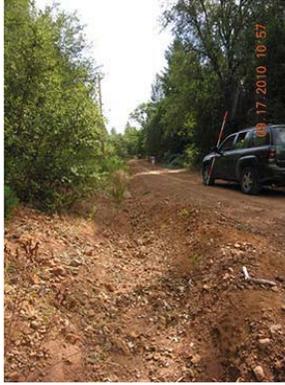
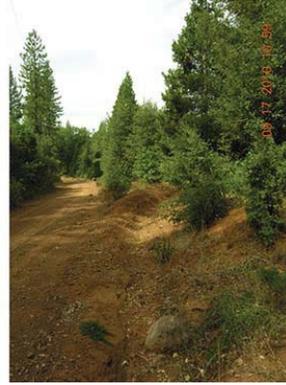
- (ii) Site 75. This flat segment of the road has a section of ditch 65 feet long by 3 feet wide that is poorly maintained on the east side and that had begun to erode and narrow the drivable portion of the road surface. The ditch directs water and silt onto

a flat basin located within adjoining forest land. Consideration should be given to rocking this short length of culvert to prevent further cutting and narrowing of the roadway.

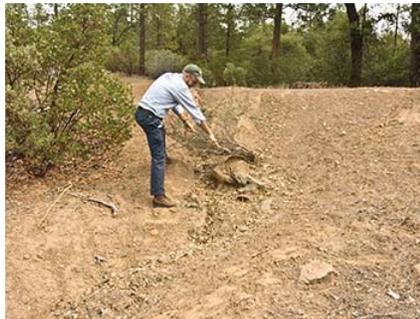
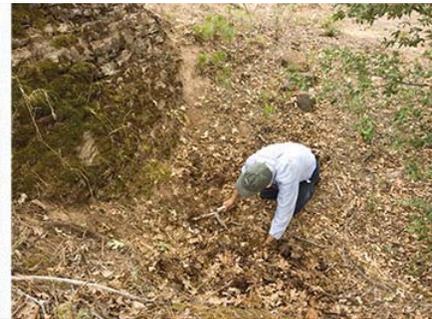
- (iii) Site 81. This site contains a 12-inch culvert with a flat rock wall armoring the roadway on the inlet side. The culvert is partially blocked on the inlet side but has a deep basin containing several feet of vegetative debris to catch flows. An ineffective rolling dip appears to have been installed over the top of the old, undersized culvert. The outslope of the dip has not been

rocked, and erosion is occurring that both narrows the road surface and is eroding the road bed. Erosion from surface flows continues down the embankment to vegetation located below the embankment. Removal of the faulty culvert and installation of a rolling dip would allow the removal of the upslope basin, improve road surface runoff, and prevent erosion damage to the downslope side of the road embankment.

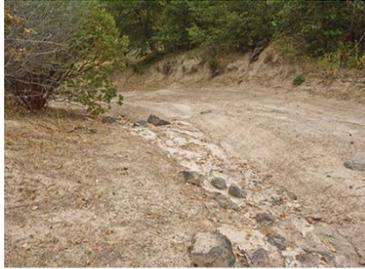
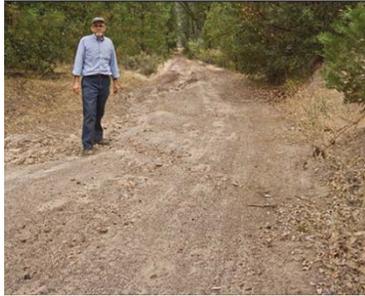
- (v) Site 89. A 500-foot section of ditchless roadway at this site shows signs of diagonal surface flows and resultant road bed rutting and erosion. Fine roadbed material has eroded to an extent where subsurface rock outcrops have been exposed at the

surface. Erosion on the inboard side of the roadbed has cut this portion of the roadway downward, and it is now approximately 2 feet lower than the outboard side. A short term, low cost fix to this road segment might include regrading of the roadway using soil from roadside berms as surface material. Any swales or other low areas that show signs of directing water onto the roadway should be redirected away from the roadway or into properly sized culverts in order to pass flows across the road prism and into stream channels on the opposite side of the road. As a permanent solution

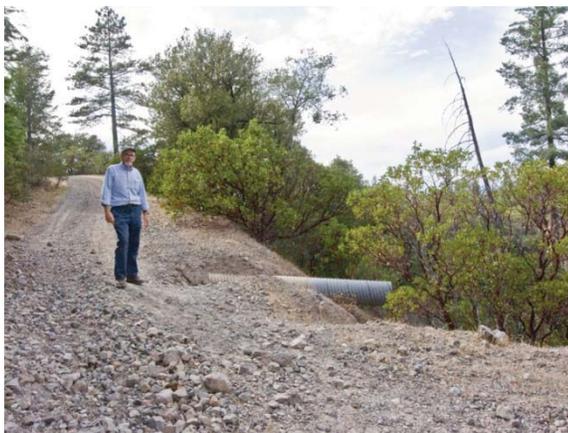
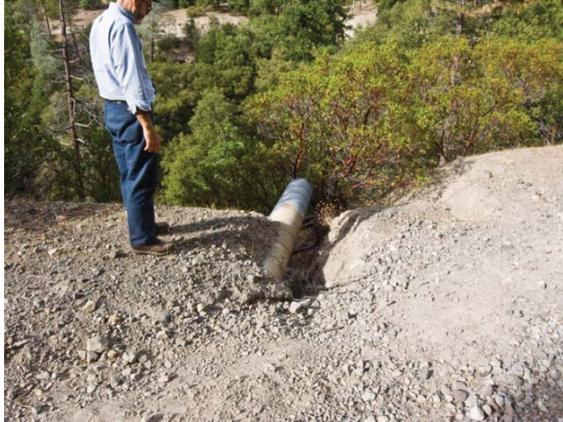
- (vi) Site 91. This portion of Ponderosa Way is just north of where the road begins its southerly descent into the canyon of South Fork Battle Creek. A 12-inch culvert has been installed to pass

storm flows out of a small ravine. The inlet of the culvert has been crushed and is almost completely full of soil and vegetative debris. The outlet has been “shotgunned” out to approximately 4 feet from the embankment. The

almost 6 feet into the passable road surface and is approximately 3 feet deep on the outslope. This faulty drainage feature has the potential to severely erode the road surface and could make it impassable in the near future unless corrected with the installation of a rolling dip or correctly sized replacement culvert that is installed with a screened and collared inlet and armored outfall. After this site, the field survey was terminated as the road became impassible for the crew vehicle.

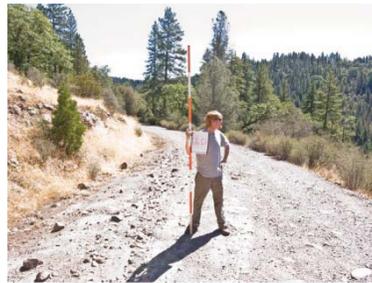
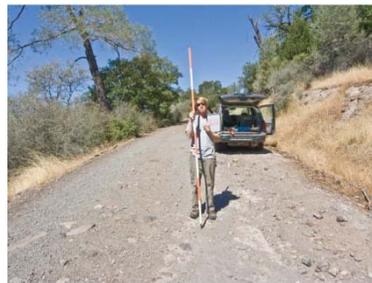
(c) *Site 66.* Along a 500-foot section of roadway cut slope at this site,

fine material from the road surface has been eroded by summer traffic and storm flows. As a result, numerous subsurface rocks and rock outcrops have been exposed at the surface. The road track shows signs of gullyng from lateral flows which have washed fine sediments over the outslope towards a watercourse below. It is recommended, at a minimum, that this portion of the roadway be graveled in order to prevent future gullyng of the roadbed material.

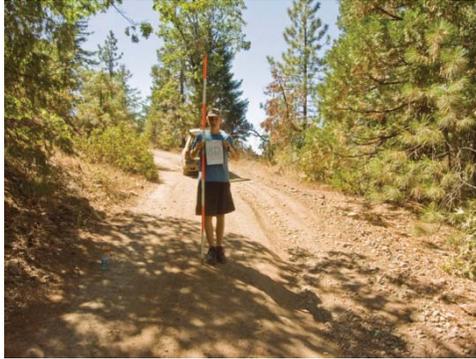
- (iii) Sites 16 to 18. Winter traffic and fine roadbed materials have resulted in significant rutting within this segment of Ponderosa

Way. Lateral surface flows have exacerbated roadbed erosion. Without repair and stabilization, surface erosion could result in rendering this portion of the road impassable and could lead to sedimentation entering any intersecting intermittent streams.

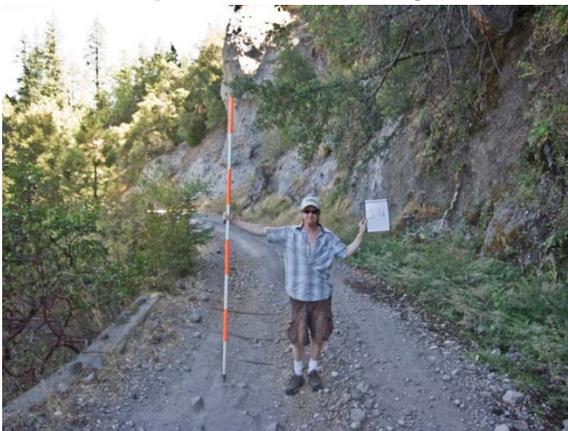
- (iv) Site 11. At this site, approximately one-quarter mile of the roadway is located along a rock outcrop, and a steep dropoff is adjacent to the outslope. The site is highly unstable, as indicated by a cement retaining wall that has been constructed

in order to hold the roadbed in place. The wall is held on the slope using rebar which has become exposed due to the loss of road surface material attributable to traffic and erosion from storm flows. Continued

deterioration of the retaining wall and its connecting rods could

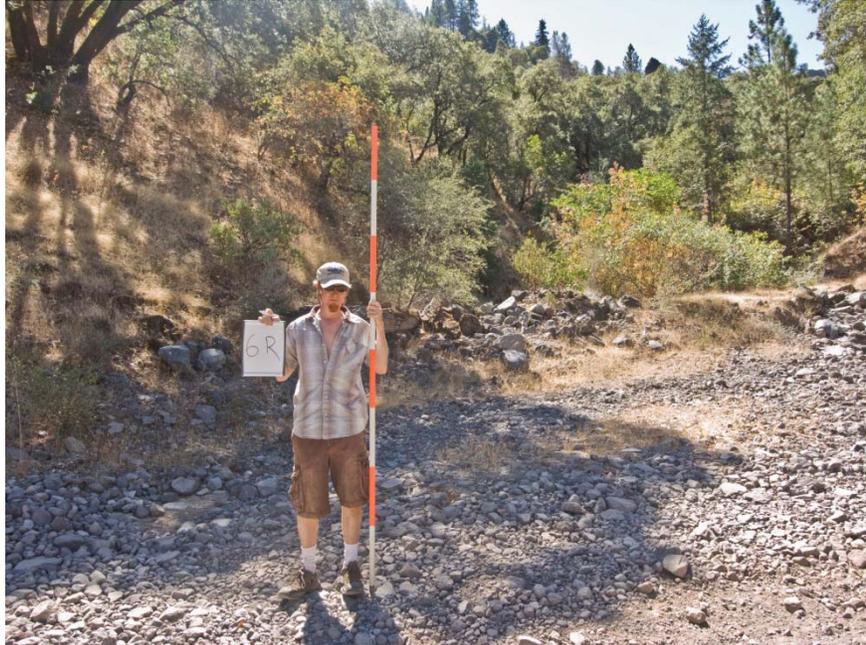
- (v) Sites 6 and 7. These sites are located at primitive low water crossing at intermittent streams. Both crossings consist of rocks

placed in road cuts that have been created by stream flows. These crossings provide no control of the stream flows being delivered from the adjacent stream channels, and rock areas of the road crossings obviously do not protect the entire portion of the road surface that is inundated during storm flows. Flows appear to be cutting into the road surface and road bed. Flows passing over the inboard and outboard edges of the roadway appear to be cutting into the roadway from the side, narrowing its operating surface. If the rocks used to create the crossing wash out during high flow events, extensive vertical and horizontal cutting of the road surface and bed could occur, rendering the road impassable. It is highly recommended that either a rolling dip with armored inlets and outlets be constructed or that a properly sized culvert be installed at this location.

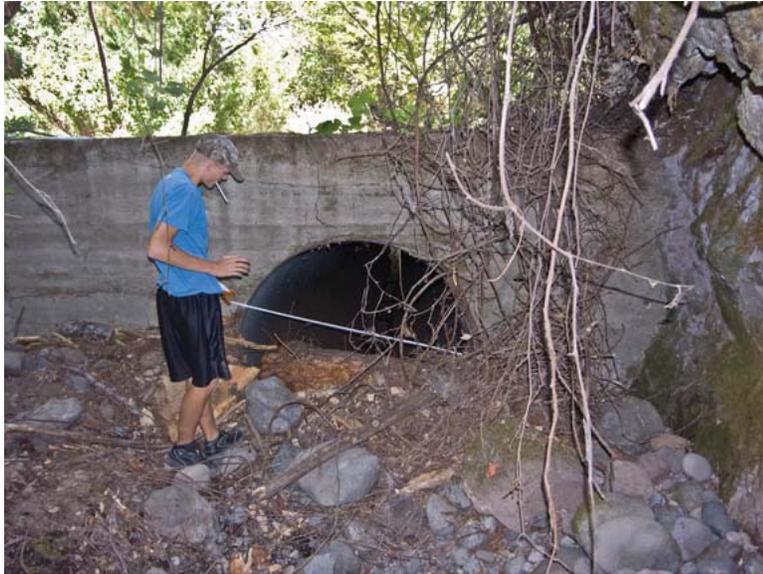
- (vi) Site 5. A well constructed 40-inch culvert's flow capacity at this site has been reduced by roughly 50 percent due to rocks and vegetative debris being lodged both inside the pipe and at the inlet. If the structure becomes completely blocked, the sizable flows passing across the road prism at this point could either

severely erode the road surface and bed or could completely wash out the culvert and its head structure. Yearly inspection and maintenance of this road feature would be a cost effective means of assuring its continued operation.
