## 2017 Ponderosa Way Road Assessment and Sediment Reduction Plan, Tehama County, California

PWA Report No. 171019201  
July, 2017

Central Valley Regional Water Quality Control Board (CVRWQCB)  
Proposition 1 Timber Fund Grants Program

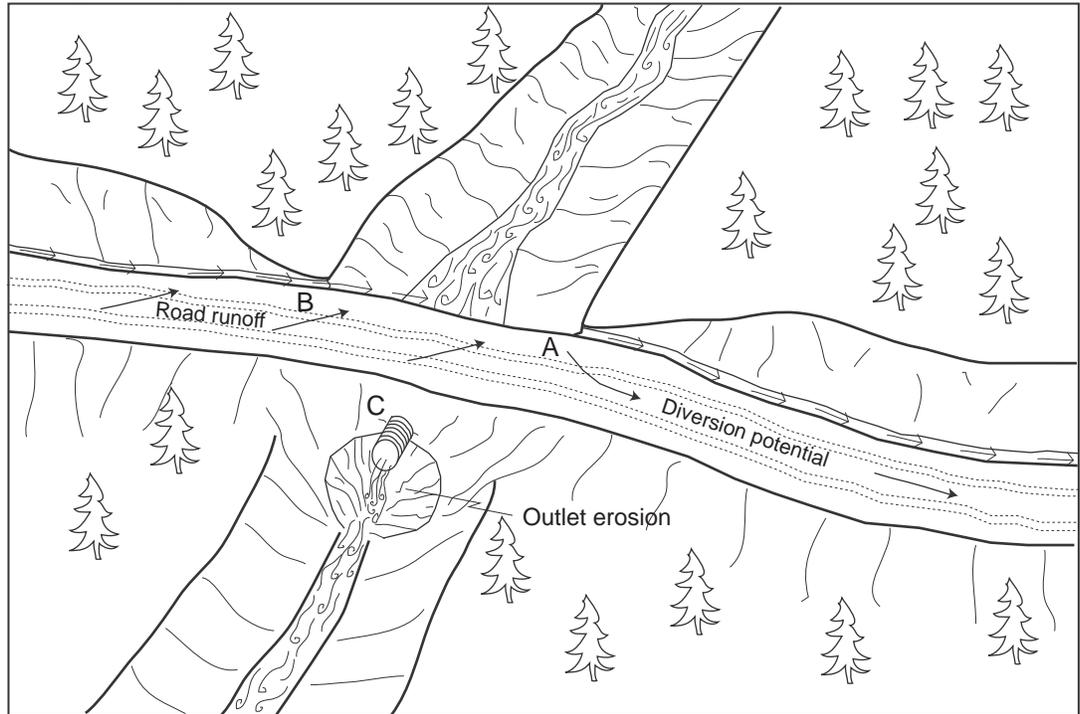
## Problem condition (before)

- A - Diversion potential
- B - Road surface and ditch drain to stream
- C - Undersized culvert high in fill with outlet erosion

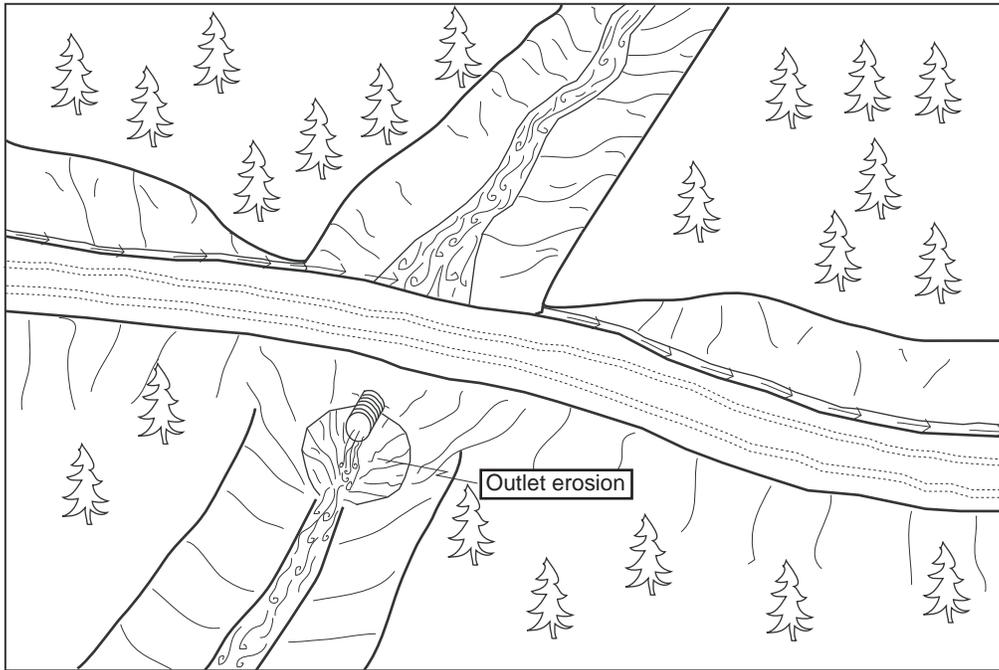
**Problem:** Culvert set high in outboard fill has resulted in scour of the outboard fill face and natural channel.

**Conditions:** The existing stream crossing has a culvert sufficient in diameter to manage design stream flows and has a functional life.
